advice series

A GUIDE TO THE REPAIR OF HISTORIC ROOFS

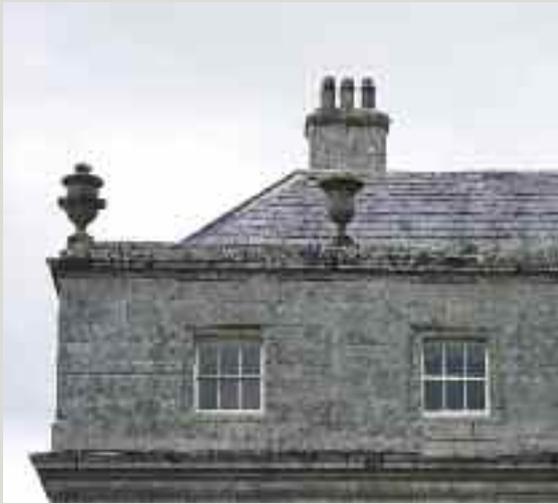
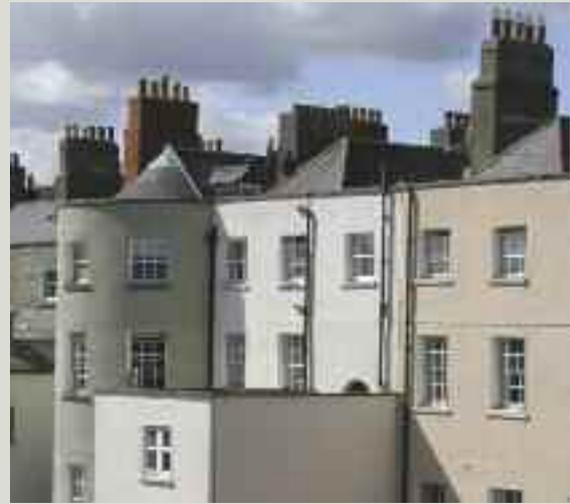
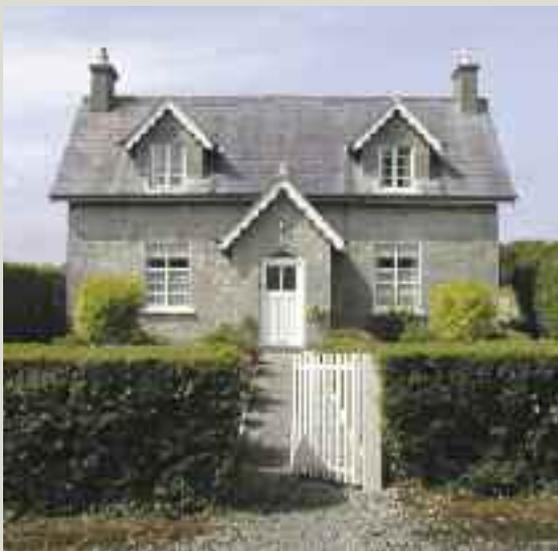
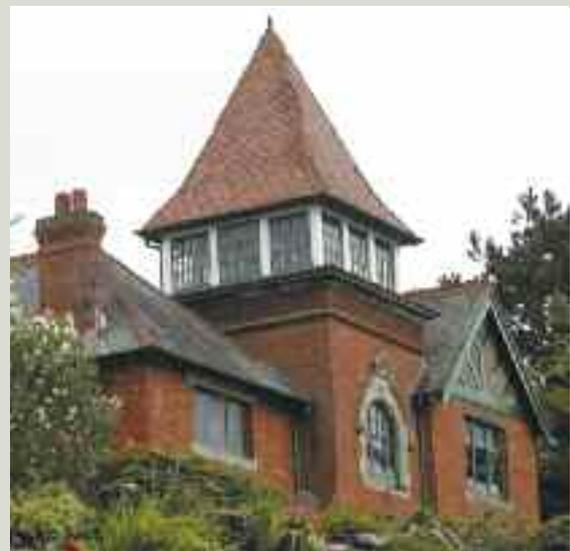
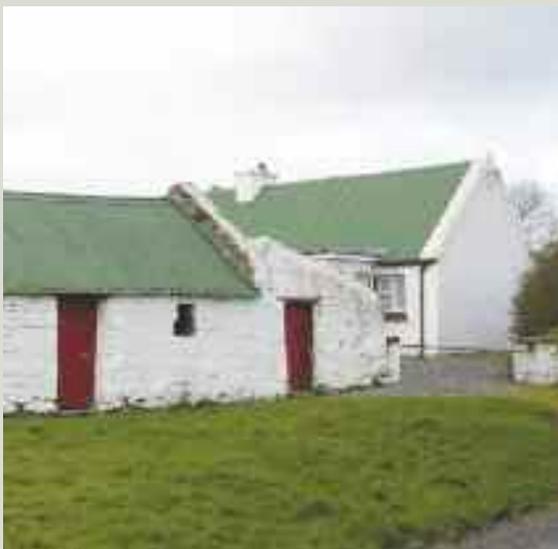
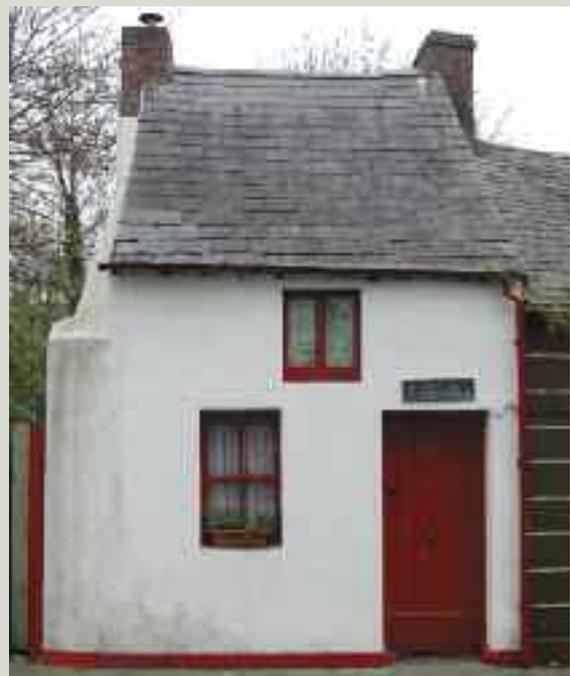
Irish roofs take many forms; the style and choice of materials used were influenced not only by the available materials, but also by architectural fashion

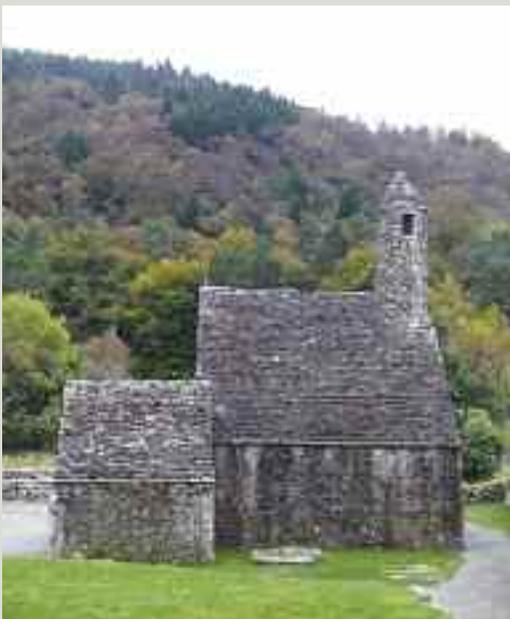
Saint Kevin's Church, Glendalough, County Wicklow. The steeply pitched roof of local stone was built up by corbelling and is supported on walls almost 4 feet (1.2m) thick

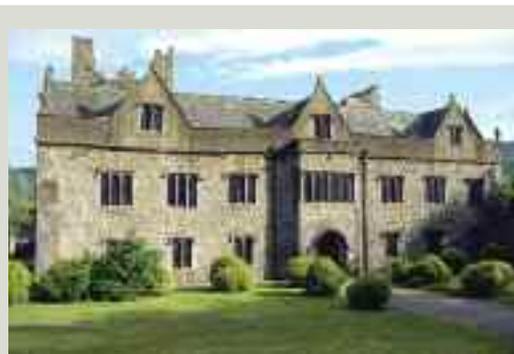
Tower houses were heavily fortified, with their roofs concealed behind battlements. In contrast, the architecture of the sixteenth and seventeenth centuries brought the roofscape increasingly into full view. At Ormond Castle, County Tipperary, the remains of the earlier tower house can be seen rising behind the Elizabethan mansion with its then highly fashionable dormer gables

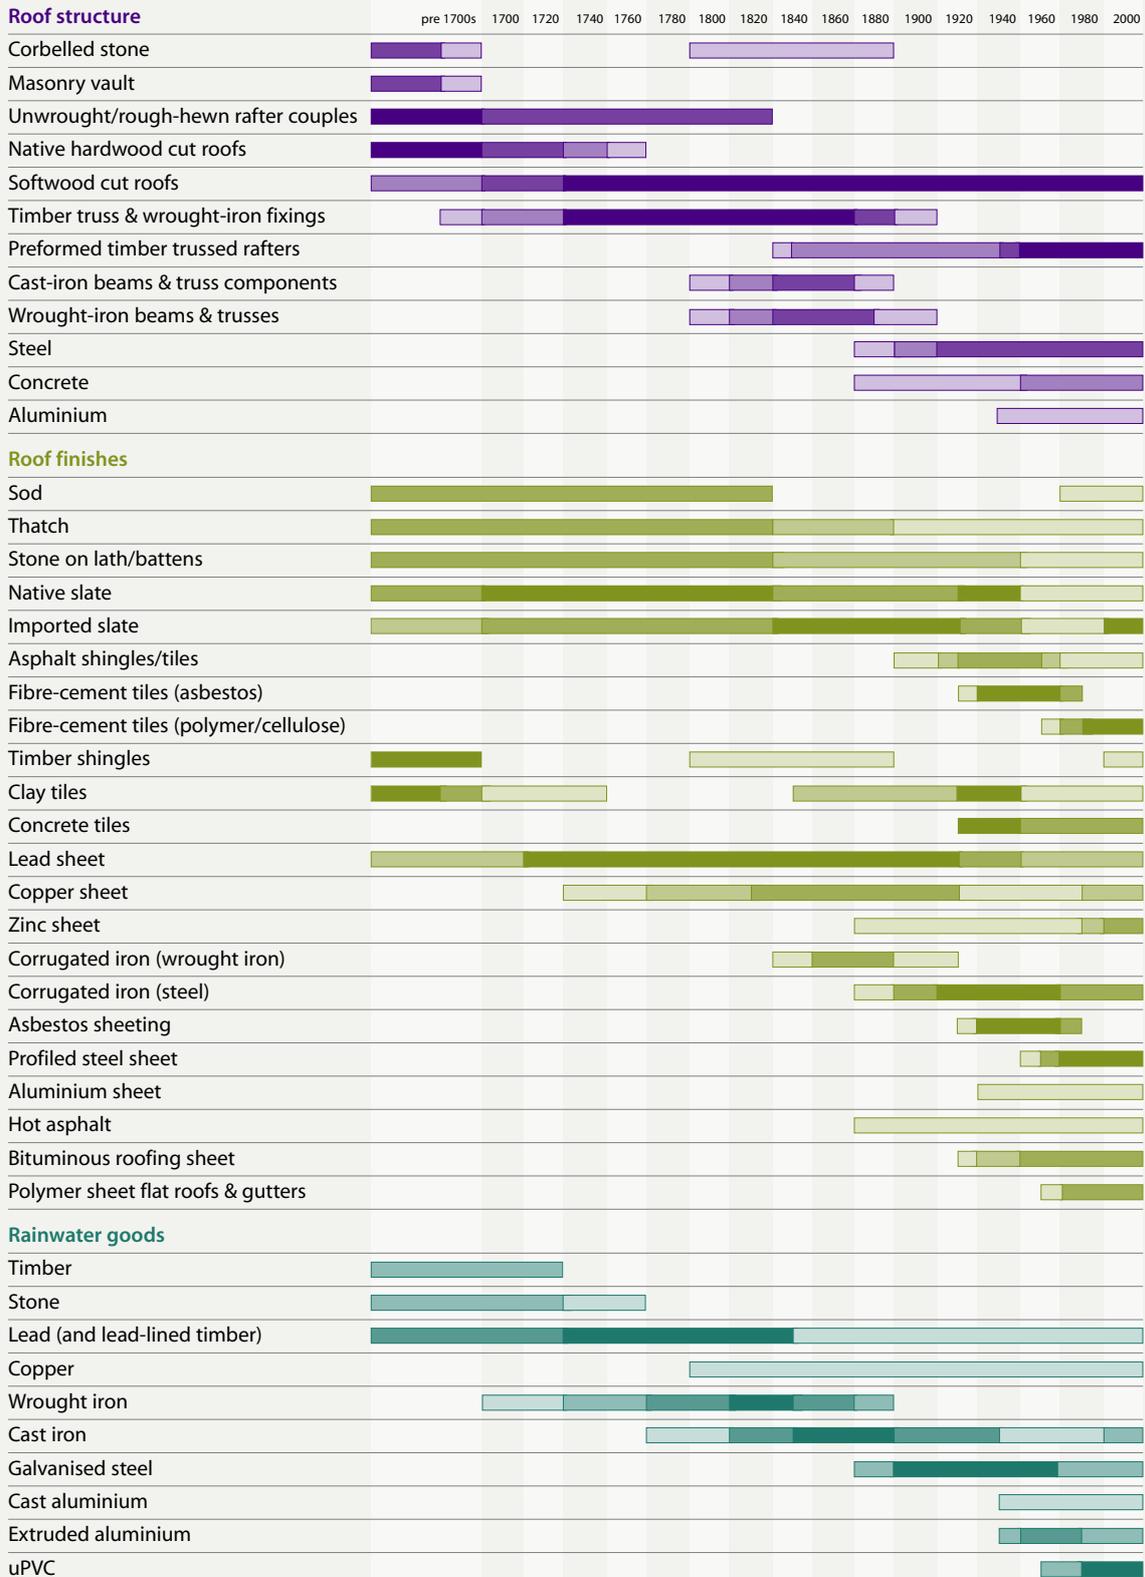
The degree of shading relates to the extent of use of the roofing material: the darkest shading indicates periods when the material was in widespread use while the lightest shading indicates periods when it has been found in use in isolated examples. In the periods where no shading is shown, there is no evidence of use of the material or it was not yet invented.

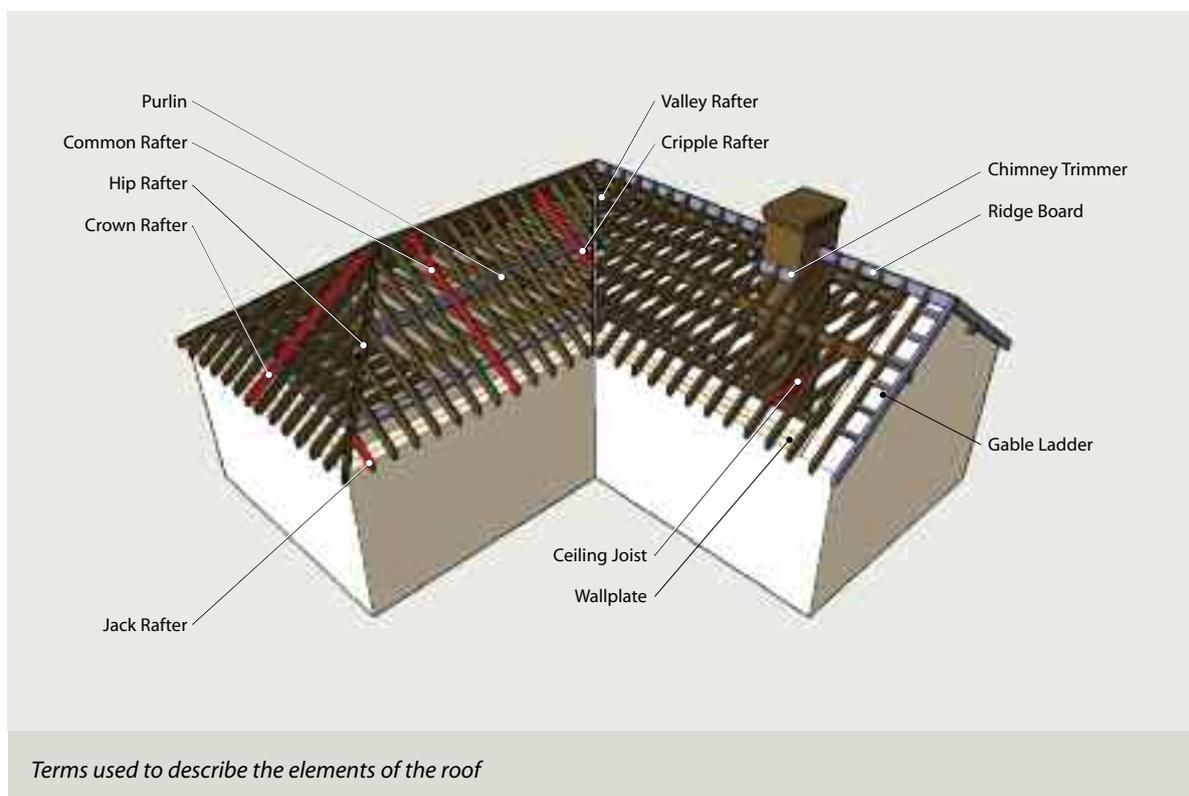
a steep pitch to prevent rainwater soaking into it. In many cases, a thatched roof may still be found beneath the metal covering. Similarly, the position of structural elements such as chimneystacks can provide clues to the date of a structure and to the internal layout of the building. Exposed chimneybreasts projecting from the gable ends of a house may indicate an English influence in the design, while a chimneystack in line with the main entrance of a vernacular dwelling denotes a central hearth protected by a jamb wall.

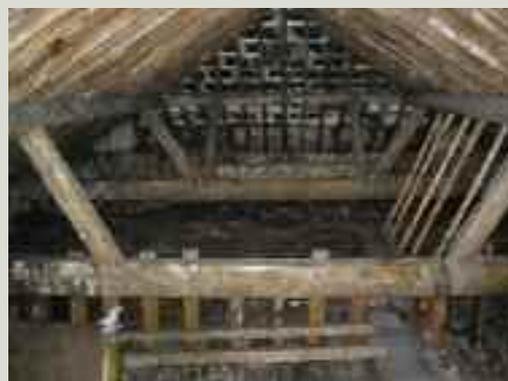
An eighteenth-century re-roofing of a tower house using imported deal

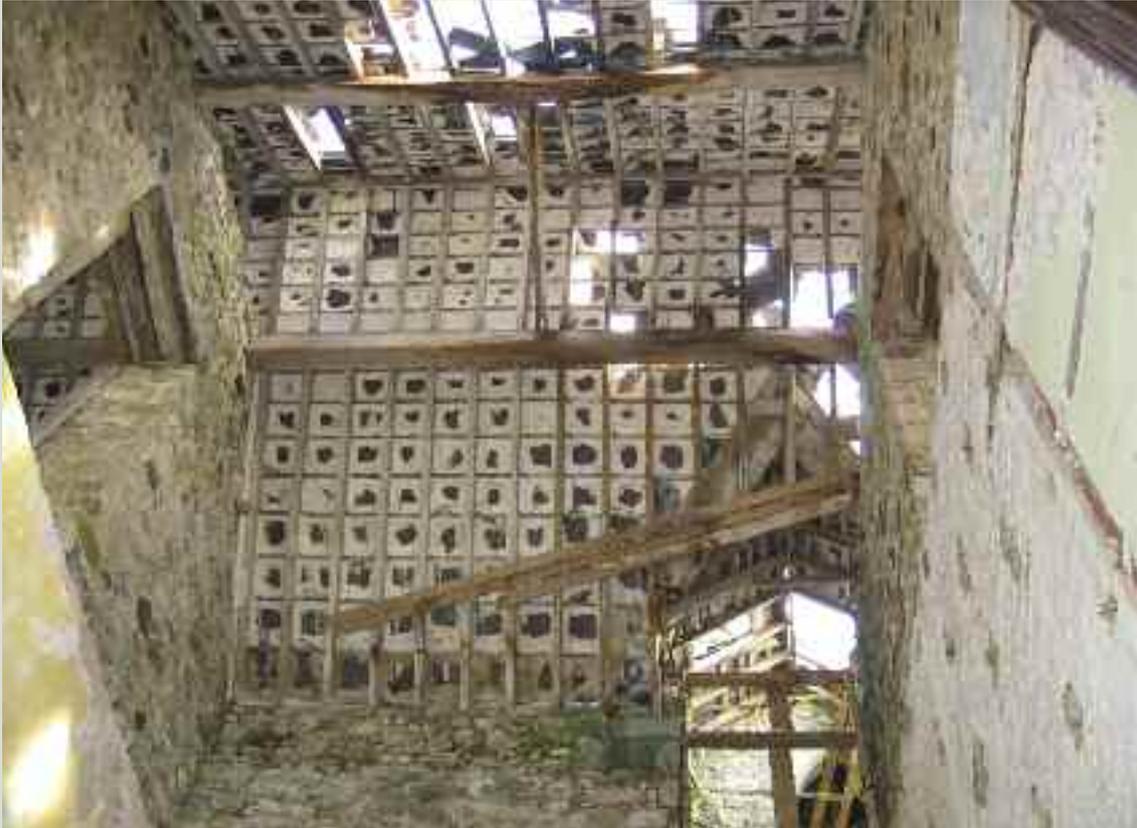
A roof detail particular to Ireland was the practice of continuing the masonry cross walls up into the roof space. Purlins were placed to span between the cross and gable walls to support the common rafters. This proved to be a very economical use of timber and also reduced the amount of skilled carpentry work required

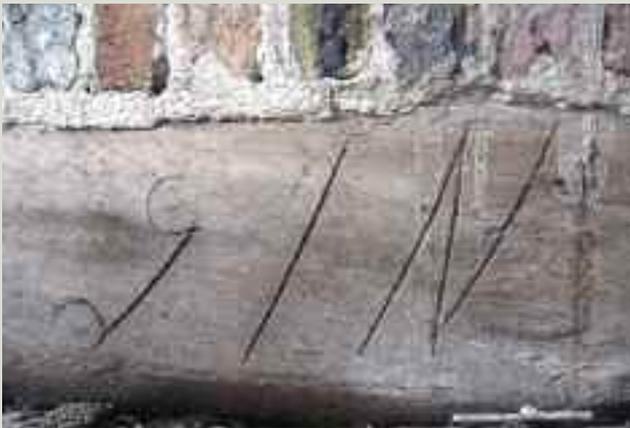
Merchant mark 'g I N' on this bay bressummer was exposed during works to repair this beam and the bay roof. Timber marks, where found, should be recorded and preserved and repair works should avoid concealment

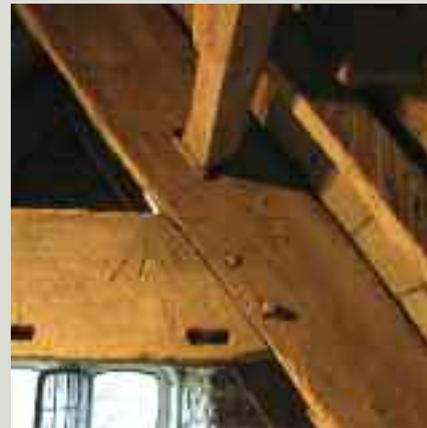
A survey of the timber structural elements of a roof often reveals merchant, religious or assembly marks on the historic timbers. These assembly marks on the oak timbers helped the carpenter to assemble the frame once on the roof. Note the pegged joints and the housing of purlins into frames. This is how roofs were constructed before nails and other metal fixings became readily available

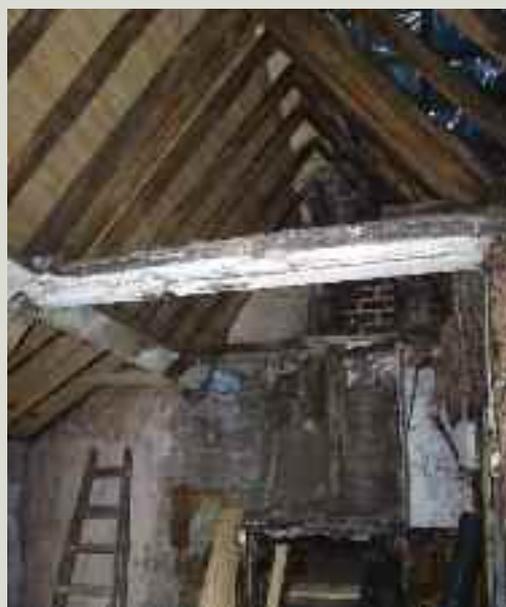
An early-seventeenth century roof showing the original principal roof structure and rafters with replacement sarking boards above (Image courtesy of Tom McGimsey, Mesh Architects)

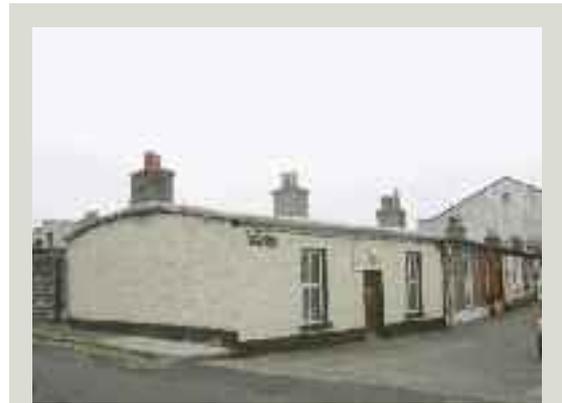
The 'Portlaw' roof was also used further afield for housing schemes, such as here in Harold's Cross, Dublin; also in Clara, County Offaly; Blarney, County Cork; and Carrick-on-Suir, County Tipperary. At one point, these trusses were exported to Germany

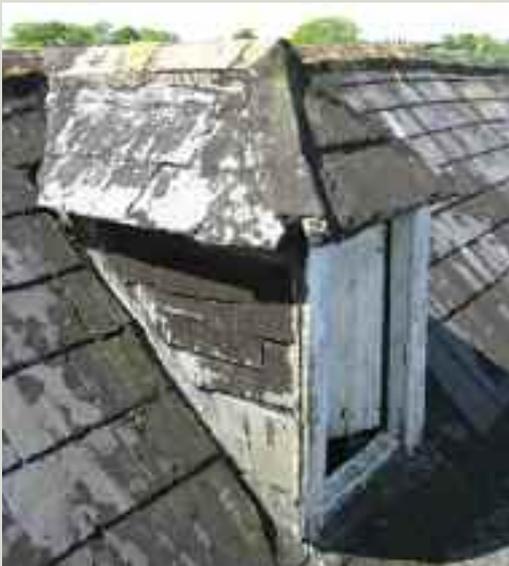
Pitch-roofed hatches, similar to dormers, were used to provide access to the roof for maintenance purposes. They were generally located in the central valleys, constructed of timber and finished with a cladding of slate or lead. By the end of the nineteenth century they had gradually been replaced by hinged cast-iron rooflights, which provided both daylight and roof access

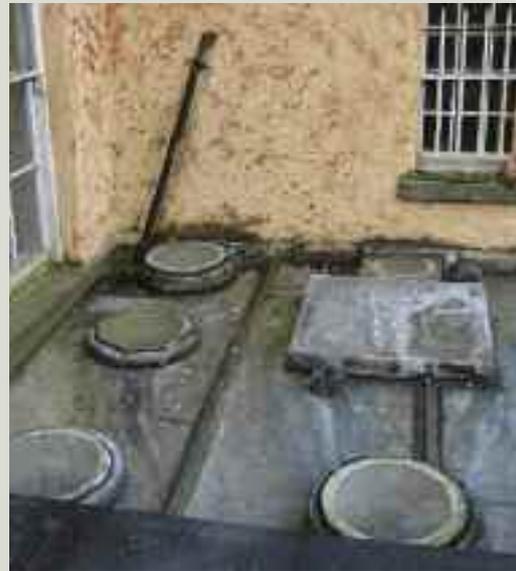
Glazed lanterns of circular and oval form were inserted into roofs as a means of bringing natural daylight into internal spaces such as landings and stairwells. Frequently these lanterns were poorly maintained because of difficulties of access and they were often replaced or covered over with a replacement roof covering. These circular glass rooflights are part of a nineteenth-century alteration

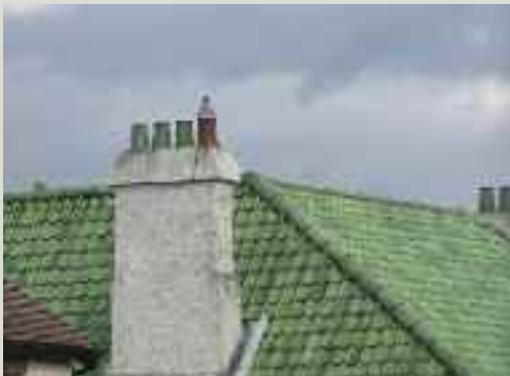
Glazed terracotta chimney pots are unusual, but examples with green, black and dark brown glazes can still be found with a simple roll-top detail. In this example, the bright green glazed pots match the glazed roof tiles. Further variations included tall dark brown terracotta pots with serrated tops and short plain black pots like crowns

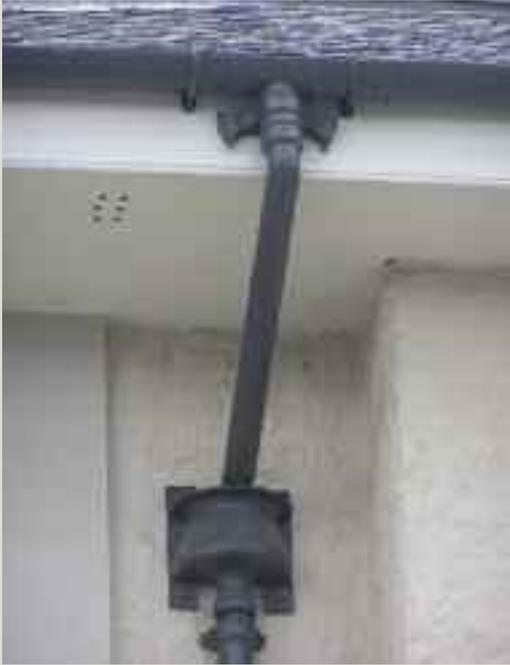
Cast-iron rainwater systems often copied the design of leadwork, but the stronger nature of cast iron enabled the use of shallow collars and two-point fixings rather than the deep collars needed to support lead rainwater goods

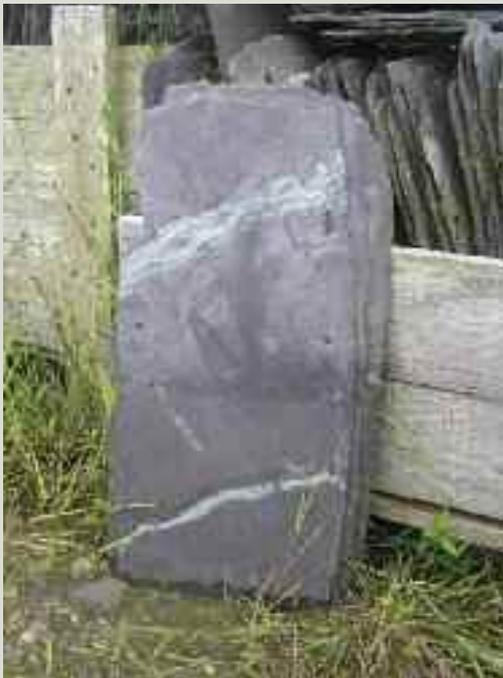
Salvaged sample of Ahenny slate. A series of quarries on the Tipperary/Kilkenny border made this one of the more prolific areas of slate production in Ireland in the nineteenth century

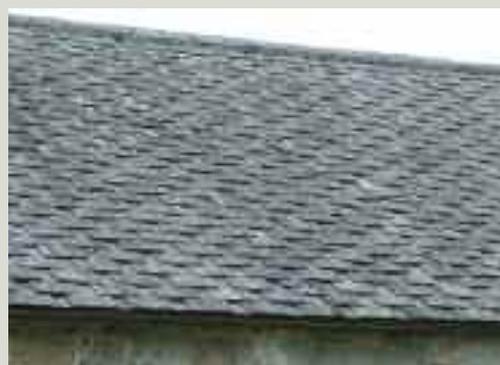
A method of slating sometimes referred to as 'open slating', 'hit-and-miss slating' or 'Scottish cant'. This slating pattern economised on the number of slates used and was primarily used for outbuildings. It is difficult to repair without face-fixing and the amount of exposure of slate surface can make the slates brittle for reuse

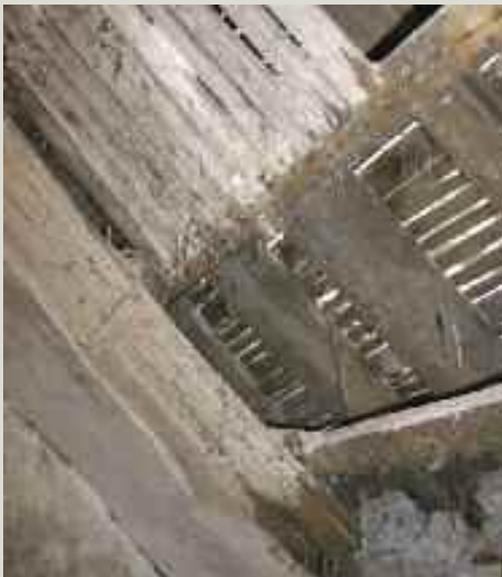
The recent discovery, within a later roof space of part of the former medieval friary in Ennis, of closely spaced riven laths fixed onto covered-over rafters substantiated the presence of an earlier structure within the historic fabric

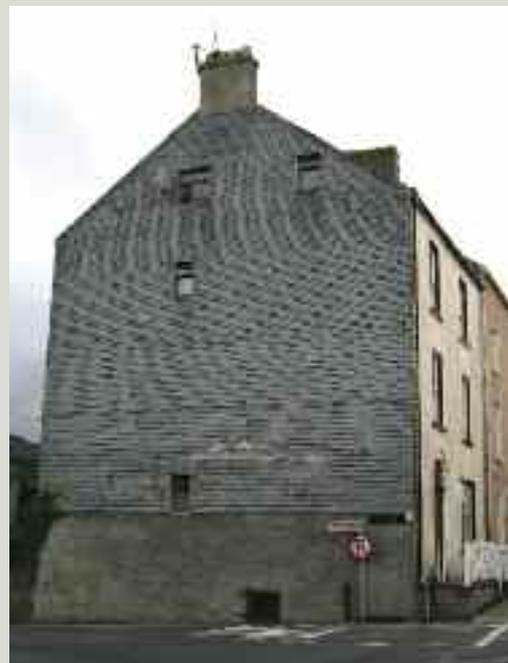
The best surviving examples of native Irish slate are most often found in vertical slate hanging, as it requires less frequent replacement than roofing slate. It is thought that this example of a slated gable is covered in Ahenny slate from the nearby Ormond quarries in the Carrick-on-Suir area

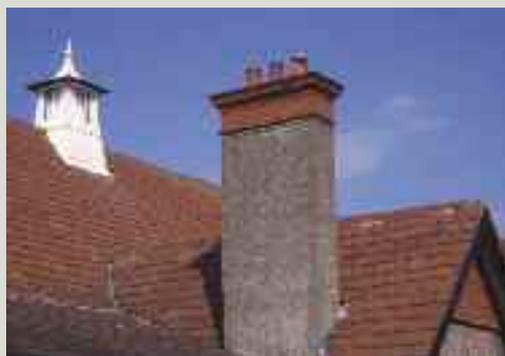
An Arts and Crafts style clay-tiled roof with tile hanging to the upper part of the gable

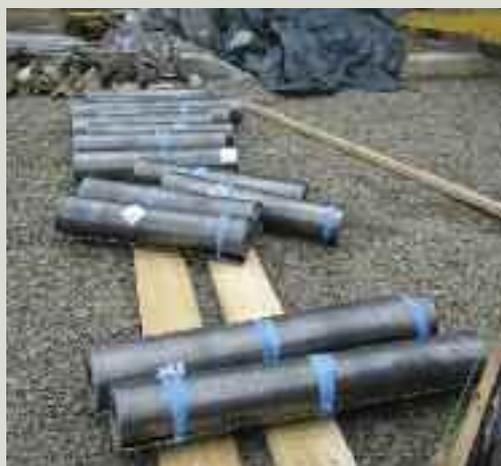
New lead sheet is supplied in rolls. Depending on the code specified, it can be exceedingly heavy and needs to be lifted with care. Despite this it is vulnerable to theft

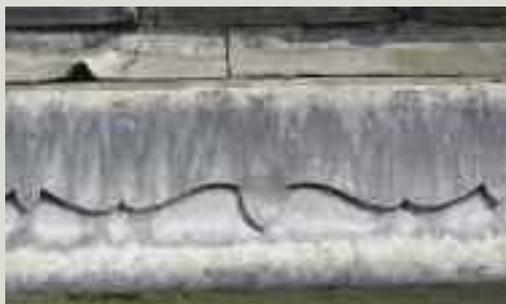
In high-quality work, the visible edges of lead flashings were cut to decorative shapes

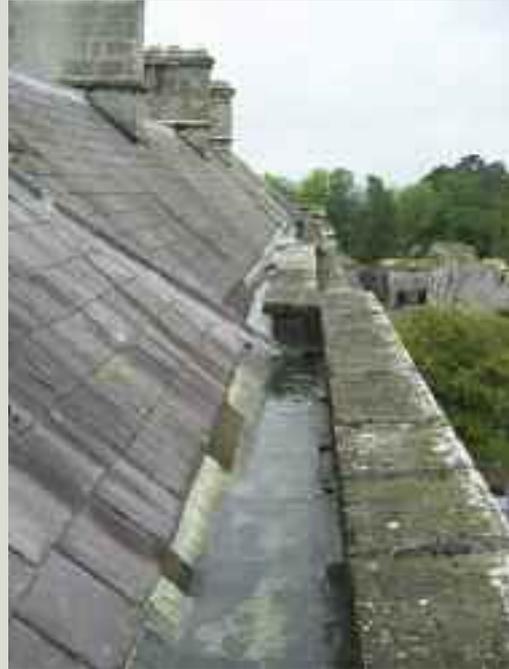
Copper can be laid to very shallow falls as in this copper-lined parapet gutter. It can be used to resolve situations where the falls necessary for stepped lead gutters cannot be achieved

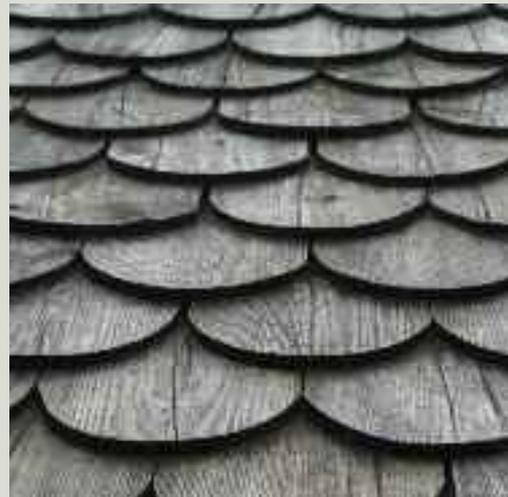
Now usually machine-sawn cedar, chestnut or oak, shingles were traditionally cleft or split. They can be found on the roofs of buildings such as a cottage orné or on decorative architectural features such as roof lanterns or lych gates

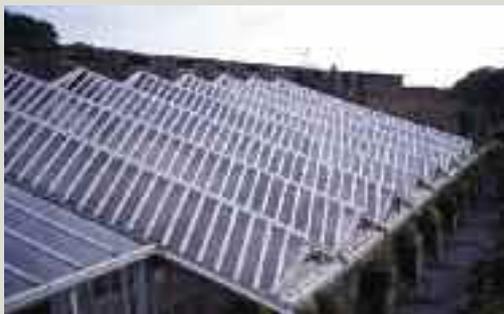
Glass roofs, using timber or iron structural elements, were used on conservatories and greenhouses and can be extensive

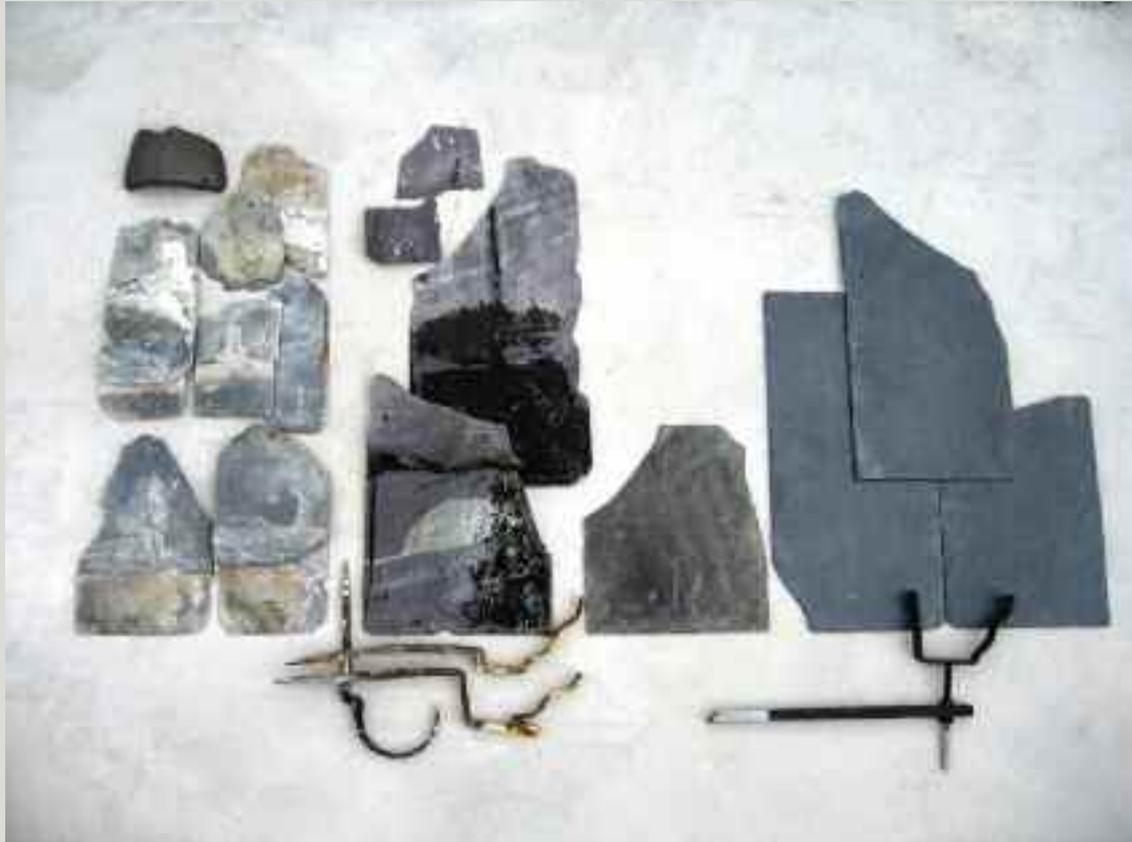
This set of slates indicates a sequence of re-roofing projects, over a period of centuries, on an early eighteenth-century country house. On the left, the small greenish, hand-dressed slates, held in place by pegs fixed into lime mortar, are thought to represent the original roof covering. Clay tiles may have been used to cover the ridge; the fragment shown here (top left) was found in the attic space of the house. An extension to the house in the 1800s appears to have been the impetus for re-cladding the entire roof with a blue-grey slate in a gauged slate pattern, possibly Ahenny slate (second from left). This roof survived until the mid-1960s, when neglect over time had caused serious damage and undermined the roof covering. The roof

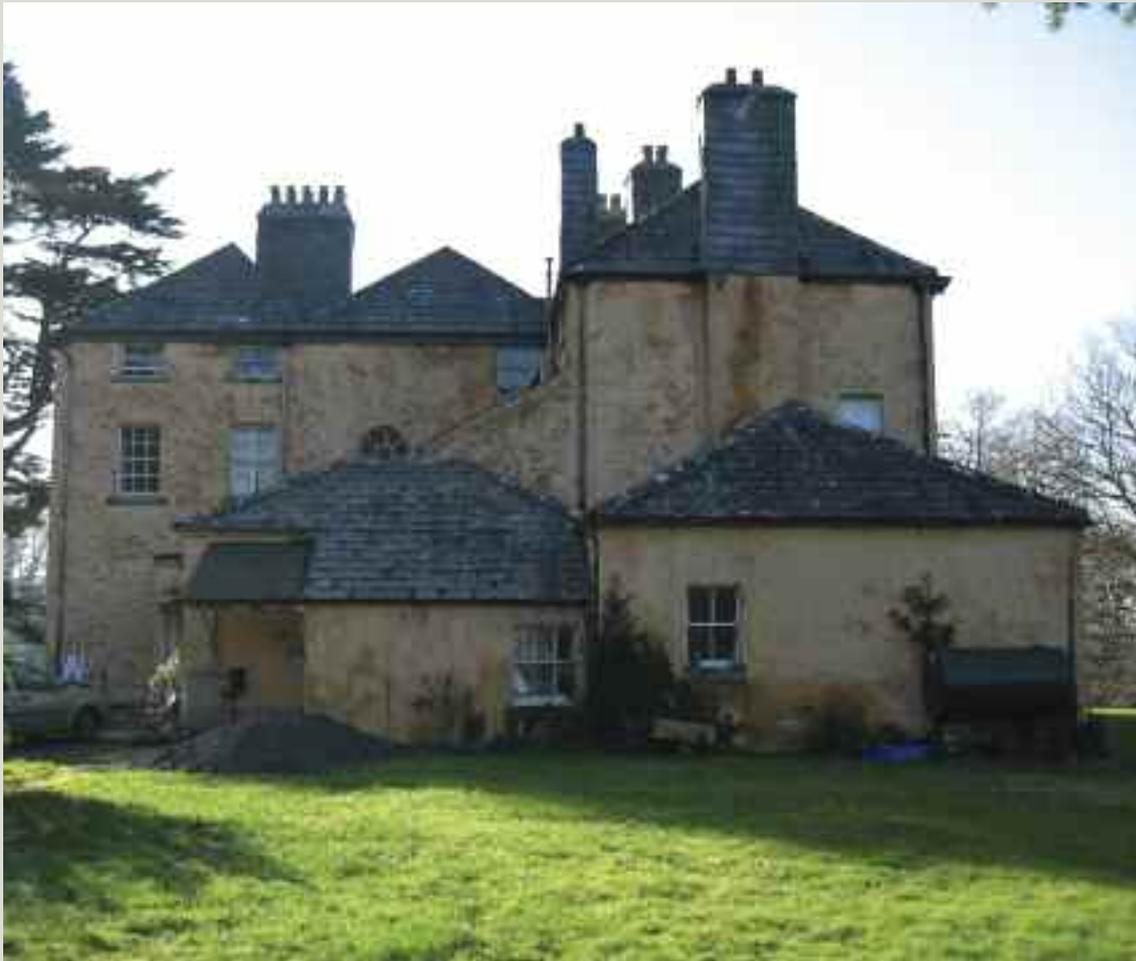
This house has a particularly interesting roofscape, complex in form with several valley gutters and a series of slate-clad chimneystacks with plain clay pots. This type of roof is known as a gauged slate roof because of the use of courses of diminishing slate sizes from eaves to ridge, probably of imported Welsh slate. The ridges are covered in stone, bedded in lime mortar with tight joints. The character and appearance of the roof were

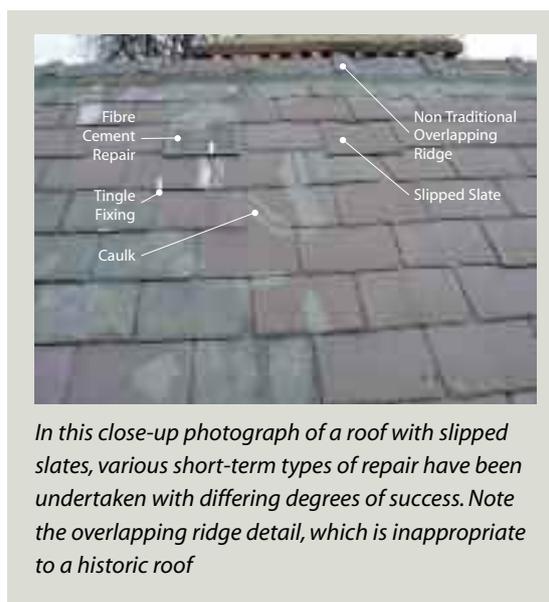
In this close-up photograph of a roof with slipped slates, various short-term types of repair have been undertaken with differing degrees of success. Note the overlapping ridge detail, which is inappropriate to a historic roof

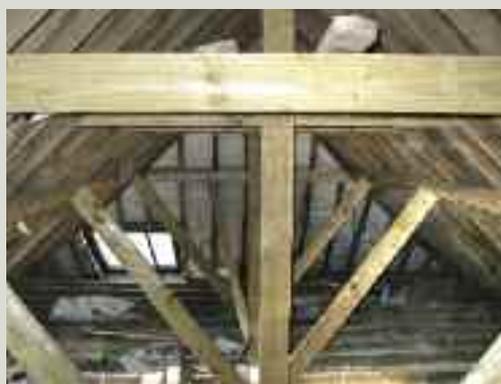
These rafters were originally undersized for their span and had deflected, causing slates to lift or slip, and thus allowing water to enter the roof space. To correct the problem, this additional support structure was added during roof repair works

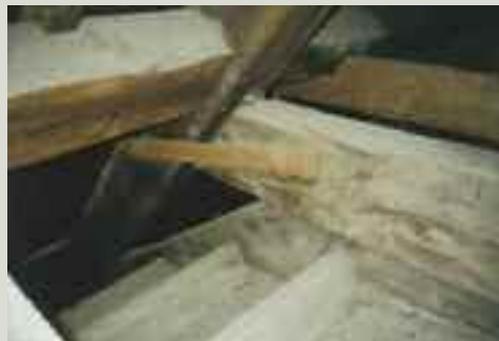
The extent of movement in this roof truss is serious, indicating not only the poor quality of the original detailing but also potentially serious movement in the main supporting walls below

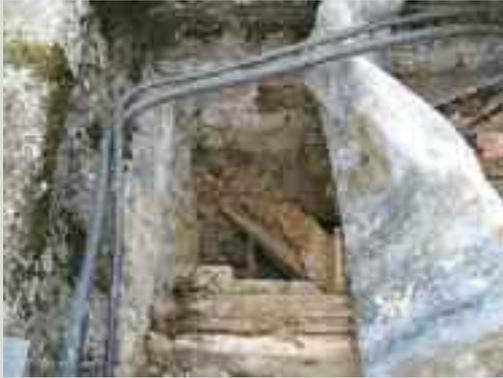
Rot beneath this section of parapet gutter resulted in localised ponding of rainwater, exacerbating the problem and leading to wet rot damage to the truss end. Note that bonding timbers embedded further down the wall may also be affected by such leaks

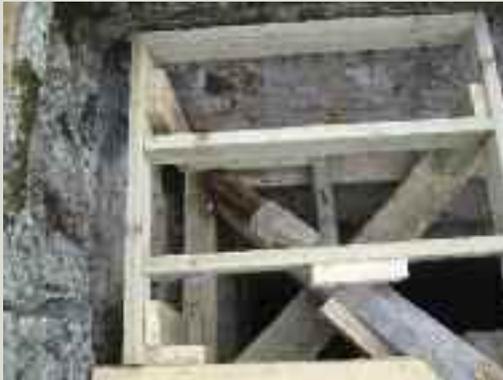
Additional support was added on the diagonal below the truss end, thus avoiding the need for new timber splice and steel connections or the local removal of the rotten timber truss end. The timber that had supported the gutter above had to be fully replaced

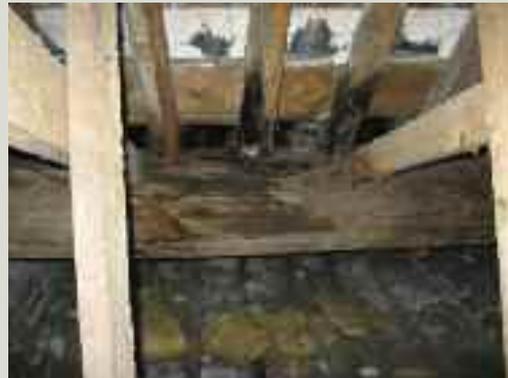
Evidence of wet rot damage to a roof beam and rafters under a tapered valley gutter. Only about ten per cent of the beam section was degraded, so no strengthening works were required to the beam. The rotted rafter ends, however, needed replacement

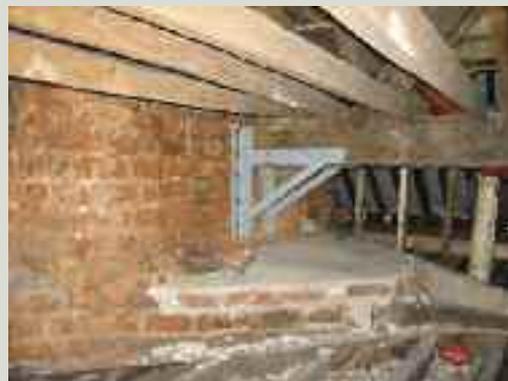
A new steel support bracket has been supplied to support this roof beam severely affected by wet rot at a chimney breast. The chimney flashings above, which had failed, were also repaired as part of these works

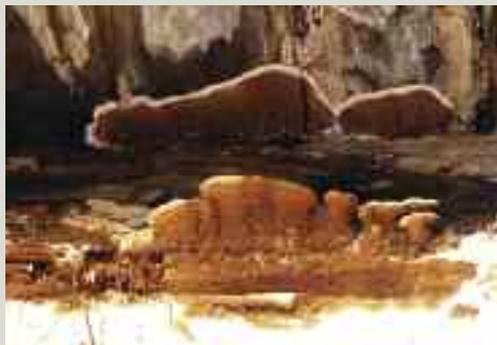
The fruiting bodies of the serpula lacrymans fungus can be identified by their rust or orange colour, usually with a white edging

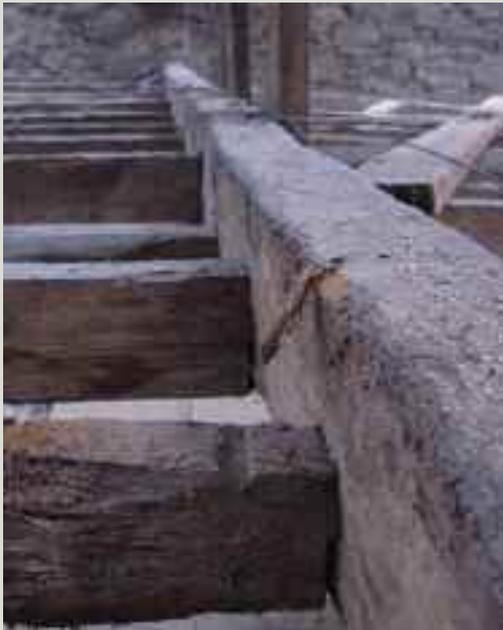
Furniture beetle has damaged only some of the faces of these timbers – these are the sapwood faces of ceiling joists. The slight shrinkage of the joists where they are mortised into the ceiling beam was not seen as problematic in this case but, if the displacement were any greater, it would need thorough investigation

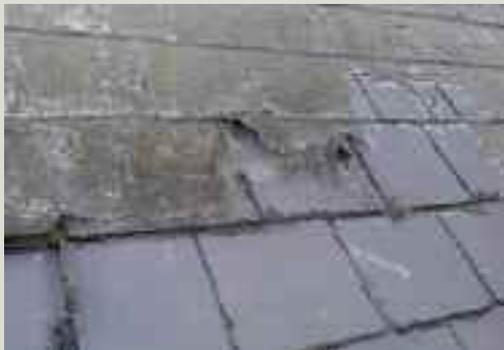
The process of covering a leaking slate roof with a bitumen covering was known as 'turnerising.' It is ineffectual and damaging and should never be carried out on a historic roof. Furthermore, it prevents the slates ever being salvaged for reuse

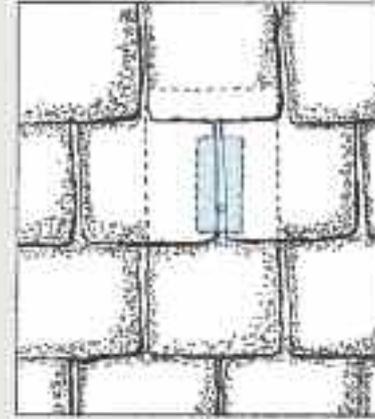
The 'bib' repair, which is used to re-affix a slipped slate

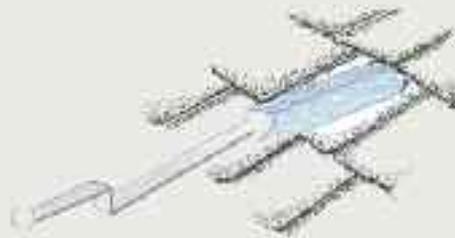
Here, a partially folded metal piece is slid under the upper slate as part of the bib repair. The metal is partially folded to allow the metal to sit above the nail head. The metal used should preferably be a painted aluminium or copper but should be matt in texture

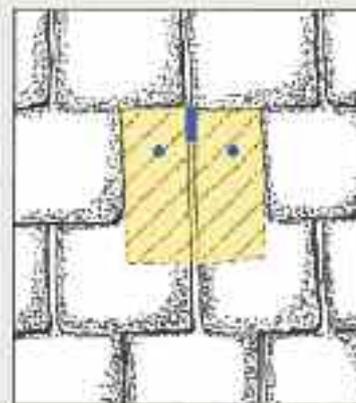
The slipped slate (in yellow) and the areas most likely as a result to spring a leak (in blue): the nail holes and the top of the joint

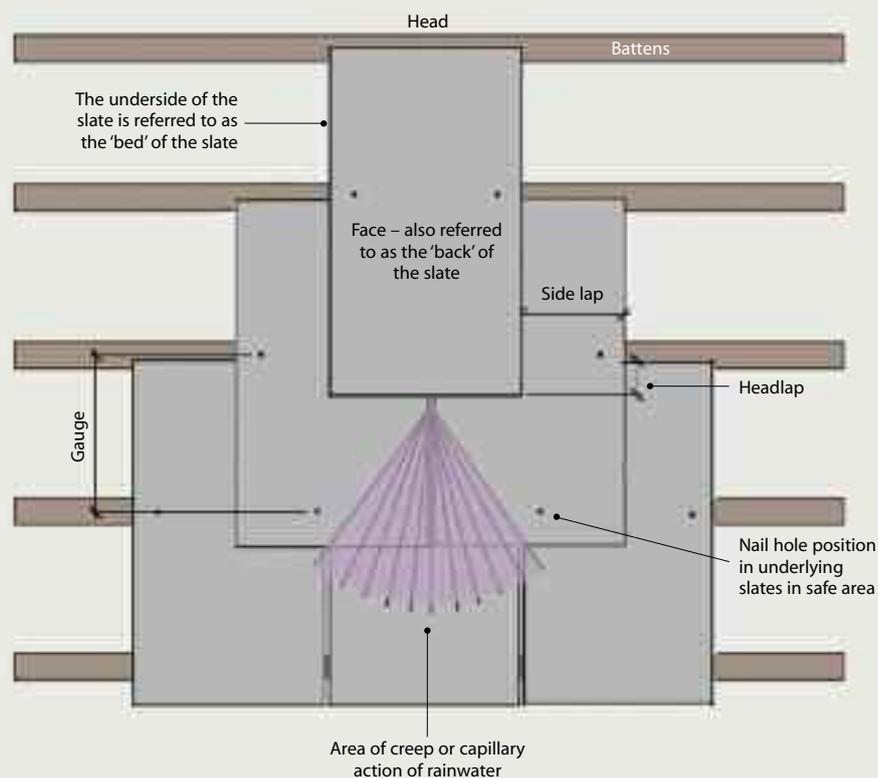
This drawing shows the terms relating to a slate and its fixings and illustrates the main area of water run-off on a double-fixed slate. If this area is cracked or holed or not adequately lapped, this will most likely be the area in which a leak will occur. If a leak occurs in the area called the headlap by way of a crack, it can be very difficult to spot, as the overlying slate conceals it from above and the

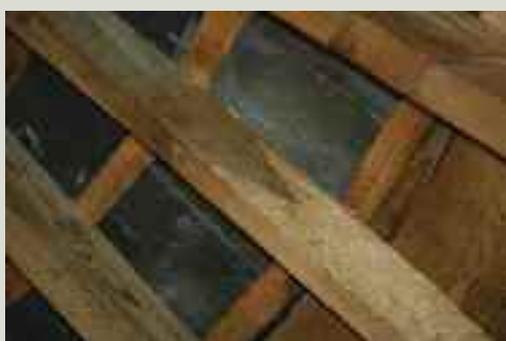
The use of a traditional scarf joint repair to damaged rafter ends is particularly worthwhile where the roof structure is exposed to view (Image courtesy of the Irish Georgian Society)

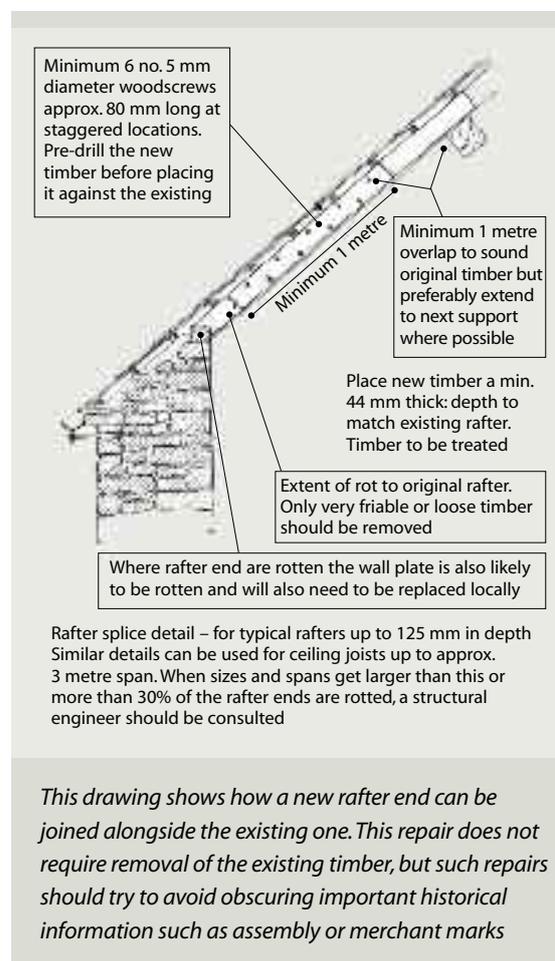
CHOOSING THE RIGHT TIMBER FOR REPAIRS

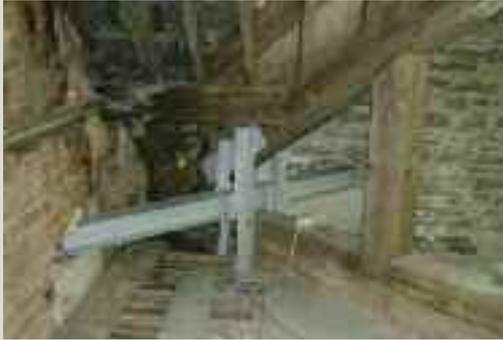
Added support has been given to the main hip roof truss at an internal valley. This repair detail used prefabricated steel elements and tooth plate connectors, but avoided the need to open up the recently repaired valley finishes and does not obscure the original truss details

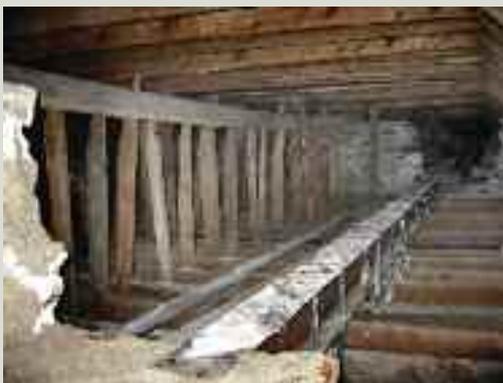
Two consecutive corrective structures to provide additional support to undersized ceiling joists. The first intervention (upper left) occurred early in the roof's history and consisted of the addition of a timber beam and timber hangers to give extra support to the ceiling joists. The new beam itself then deflected. Further corrective measures were taken using a new steel beam (lower right). Note that all original timbers were retained intact and the history of the roof and successive repairs can easily be read

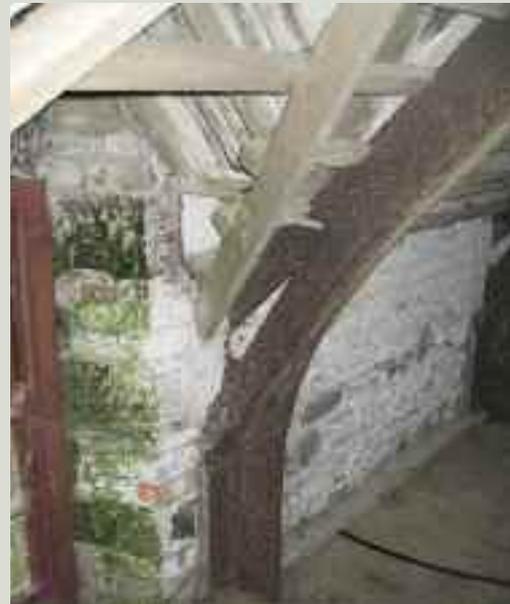
Ferrous metal roof structures should be regularly checked for corrosion, particularly at supports and where built into potentially damp masonry. Where there is significant corrosion of the ironwork, the masonry is likely to crack, as the products of iron corrosion (rust) are approximately eight times the volume of the iron itself

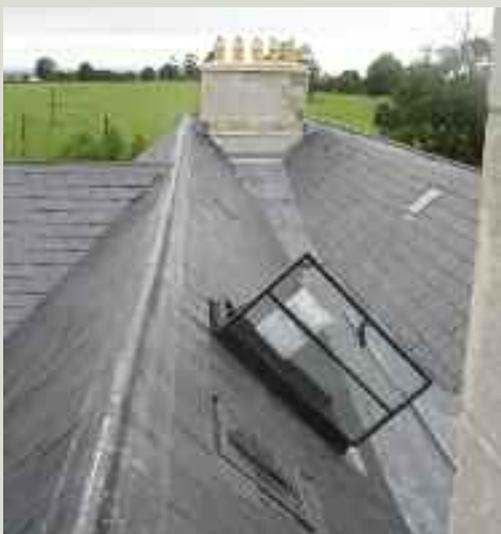
There are several contemporary products available, of which the side-opening rather than top-hung skylight type is possibly the most convenient for providing access for maintenance inspections of the roof

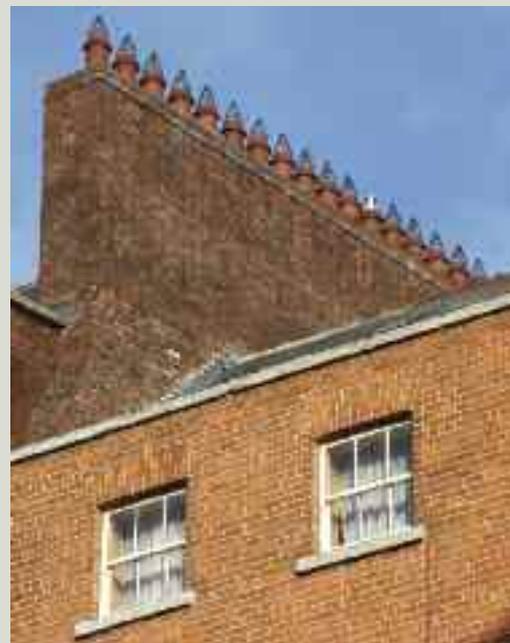
Chimneystacks are prominent features and add considerable character to a historic building. They are integral to the design as well as to the original use of the structure and, even when redundant as vents for fires, play an important role in providing ventilation to the interior of a building

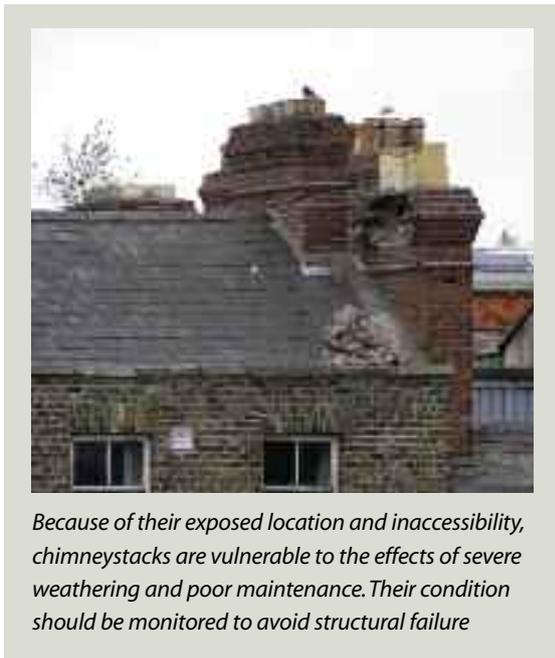
Because of their exposed location and inaccessibility, chimneystacks are vulnerable to the effects of severe weathering and poor maintenance. Their condition should be monitored to avoid structural failure

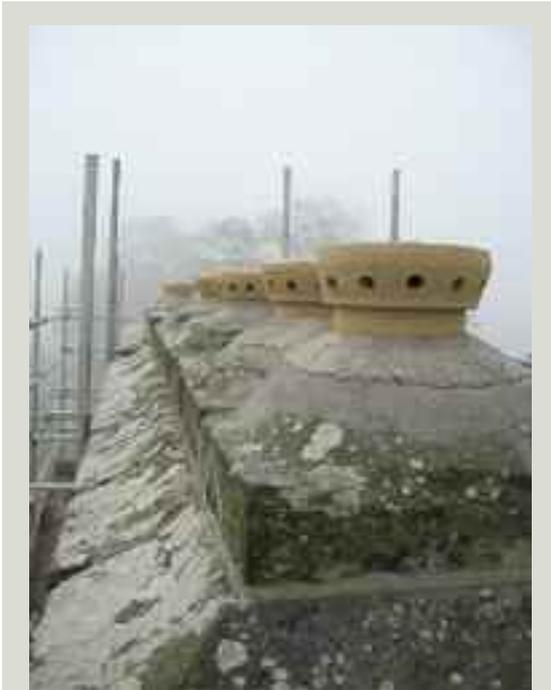
From about 1900 onwards, the insertion of chimney trays into brick stacks became standard building practice. A chimney tray is a lead tray inserted at roof level into a chimneystack, forming a barrier to moisture ingress. In combination with a DPC below the coping and with flashings at the base of the stack, water is prevented from passing through the brickwork and entering the attic space.

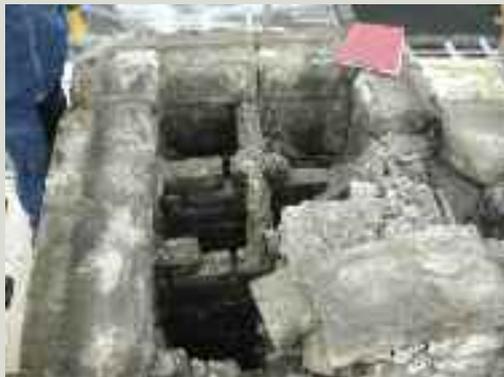
Many older flues have little more than half-brick fin walls called 'feathers' within the stack separating the flues from each other. These can be poorly tied in or even entirely missing as the result of chemical attack from soot, heat damage or over-vigorous cleaning with soot brushes
