advice series

A GUIDE TO THE REPAIR OF HISTORIC ROOFS

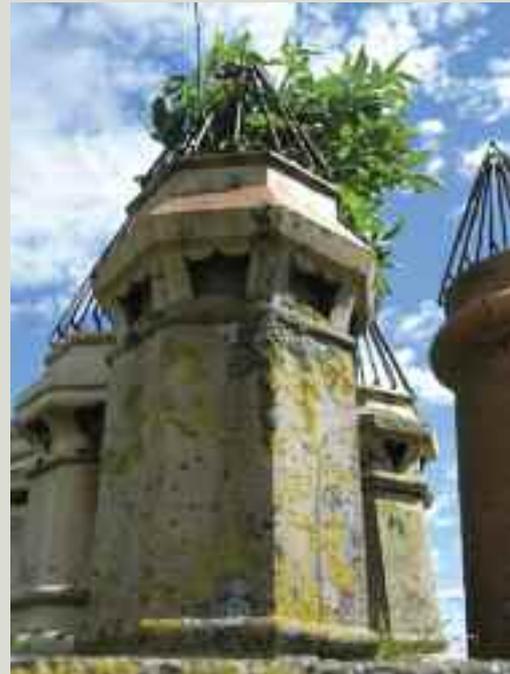
The use of wire crow guards prevents birds from nesting in chimney pots, but does not stop plants rooting in blocked flues

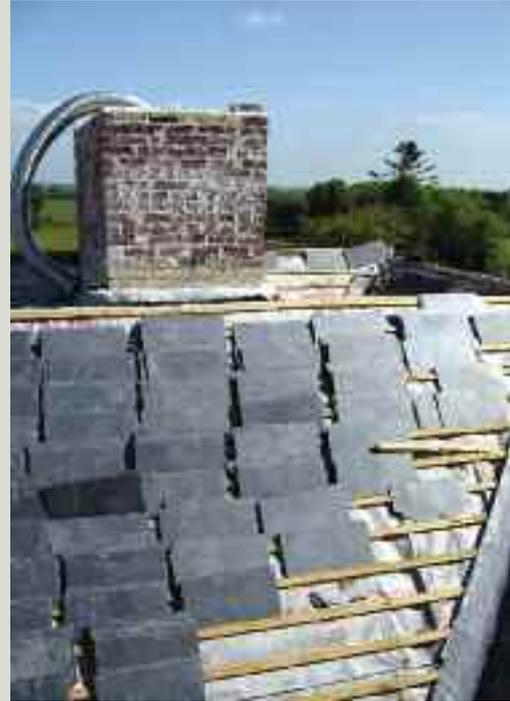
Flexible stainless steel flue being inserted into a historic masonry flue

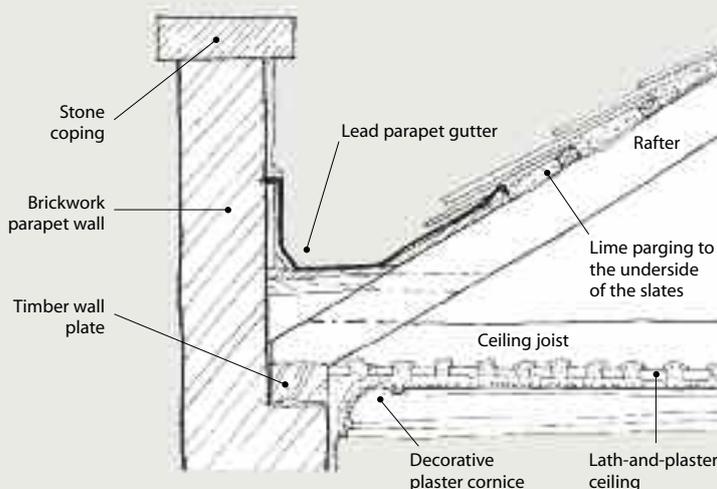
The use of lead flashings to parapets in excessive lengths that deteriorated, cracked and split under pressure from thermal expansion has resulted in water soaking into parapet walls and main walls below, often causing deterioration of the bearing ends of roof trusses, beams and joists.

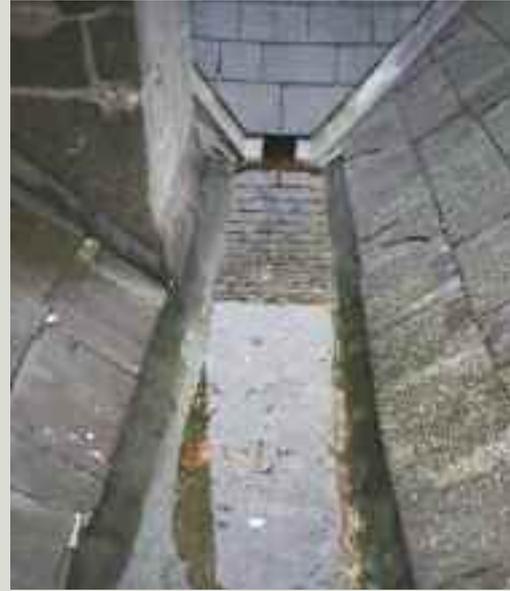
View of a defective valley gutter with a shallow fall that is now holding water. Birds' nests in the outfall of the secret gutter (seen at the top of the image) blocked this roof outlet

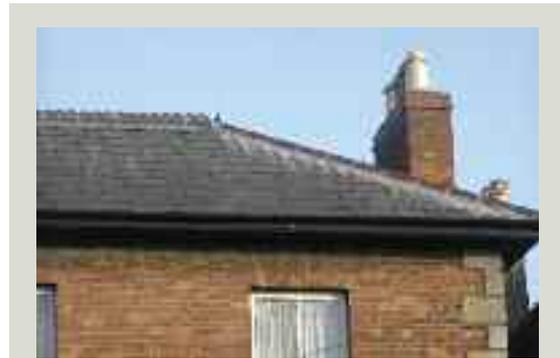
Incorrect bedding and detailing, with fat joints to the ridge and hip tiles, are visually very disruptive and inappropriate to a historic building

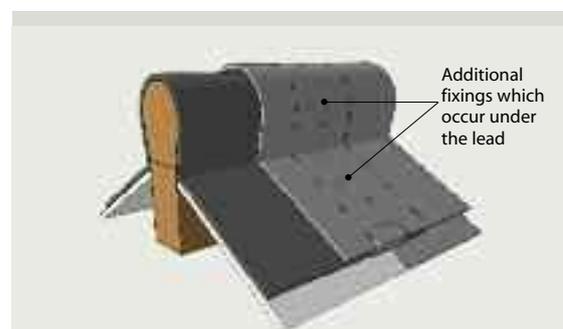
The Lead Sheet Association advises a modification to the profile of the 'broom handle' timber roll and promotes instead the use of a more elongated section in treated softwood to reduce the likelihood of the pinched lead cracking along the roll

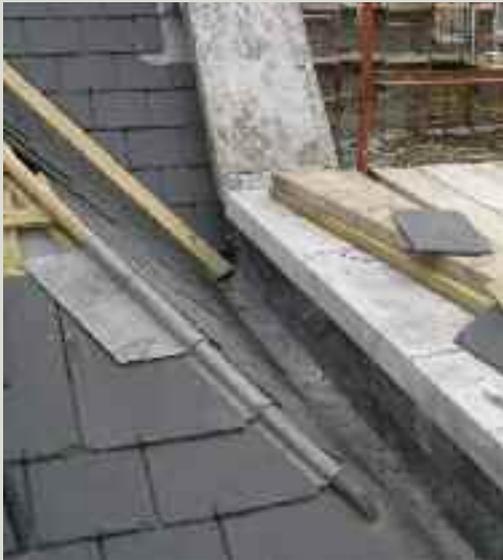
Interleaved soakers: a variation of the external lead roll is the cloaked version seen on hips of roofs, which conceals much of the leadwork below the slate courses. In this detail, the lead flaps are interleaved with the slate on the ridge or hip. If this detail requires repair or replacement, local re-slating of the roof will be necessary to access and replace the damaged leadwork

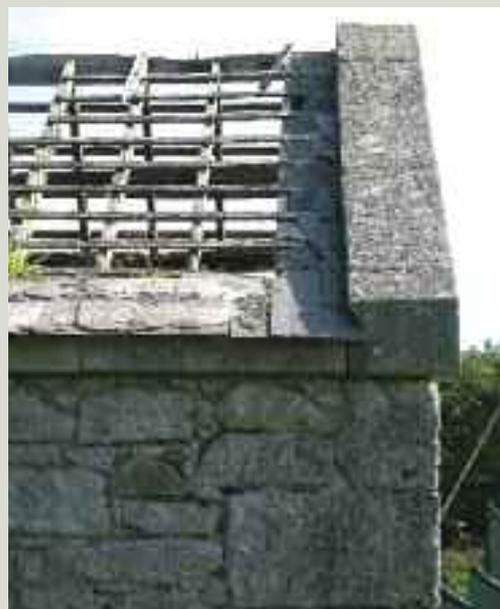
A gable detail where the verge is held or 'locked' in place with a stone coping. A particular difficulty arises with this detail if there is damage to slates set below the coping, as the coping will need to be removed to allow for repair of the roof covering

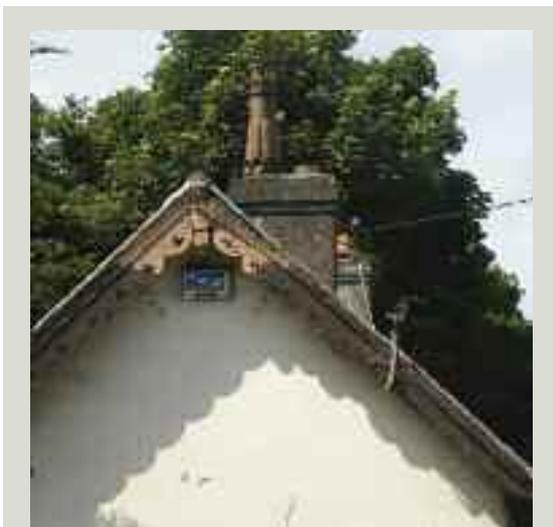
The poor condition of overhanging verges can lead to deterioration of the ends of the purlins as well as the loss of sections of decorative timber bargeboards

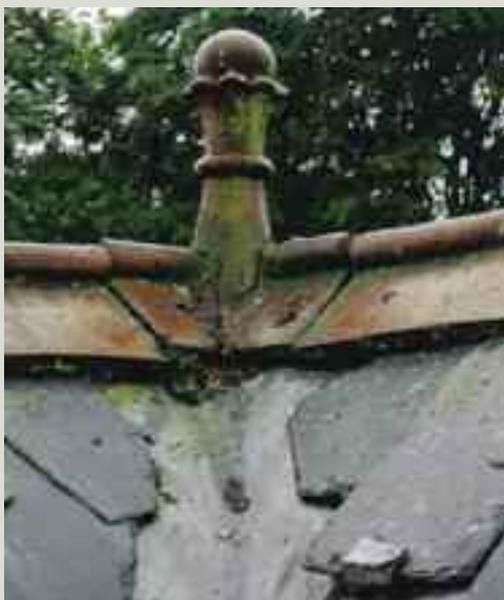
This terracotta ball finial was cracked; as part of a roof repair project it was removed, carefully cleaned and repaired before re-installment

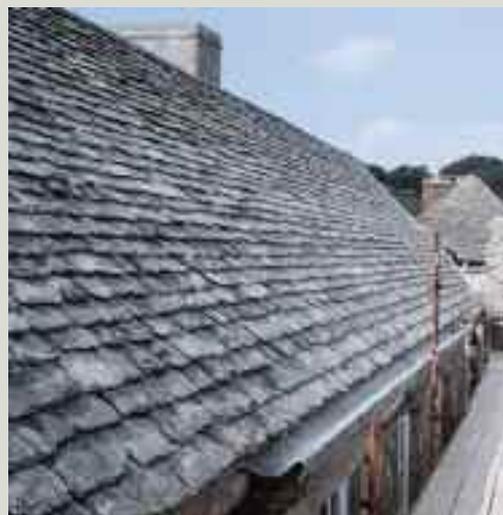
A new flush eaves gutter formed in lead along the top of the wall

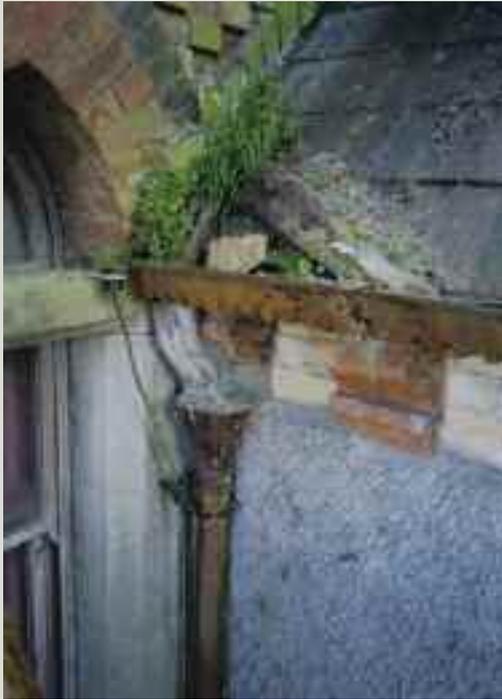
Cracked or broken rainwater goods can be replaced on a like-for-like basis with half round, box or ogee cast-iron gutter profiles which are readily available. Where castings are more decorative, such as in this case, new gutters can be cast to replace the broken sections. Downpipes should be carefully examined, cleaned down and fully refurbished on a regular basis

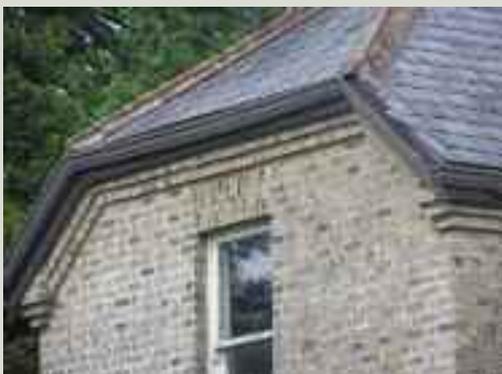
An unusual example of a decorative cast-iron gutter detail following the profile of a half-hipped roof

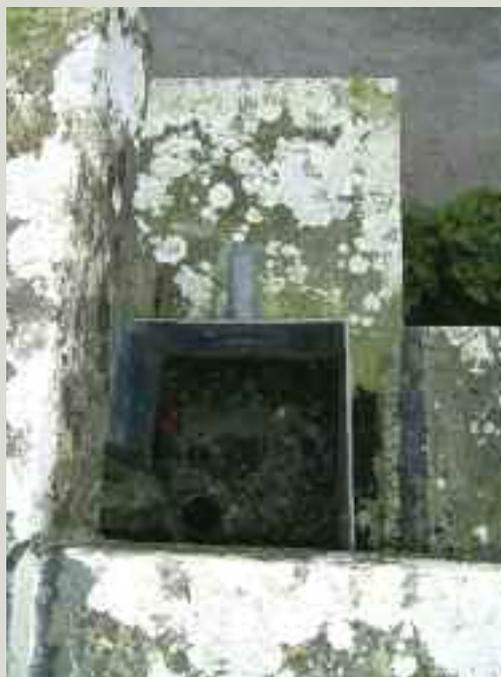
The installation of an early warning system in the form of an overflow pipe will alert the owner that the catchment pit is full and that a blockage in the gutter or hopper head needs to be cleared before excessive damage occurs

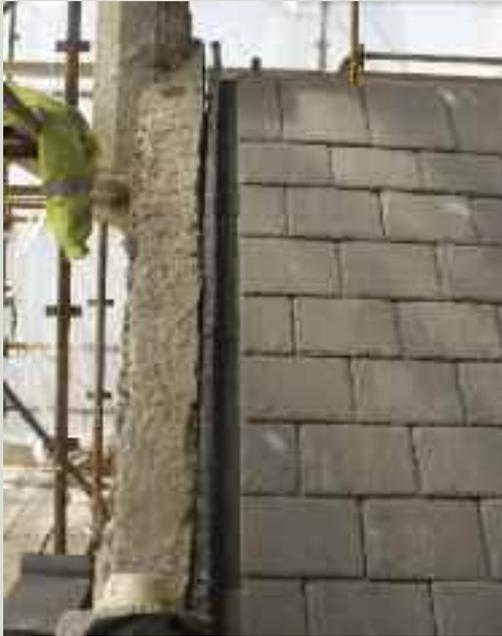
This so-called 'secret gutter' detail is not a traditional one. However, it may be recommended in instances where there is a history of water penetration below lead cover flashings at the junction with abutments, particularly on roofs of a low pitch (Note: in this image the gable capping stones have yet to be replaced)

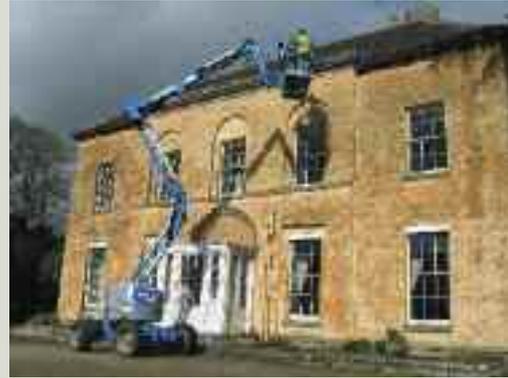
In some cases, the use of a cherry-picker may be an economical alternative to scaffolding for undertaking maintenance inspections and minor repair works to high roofs

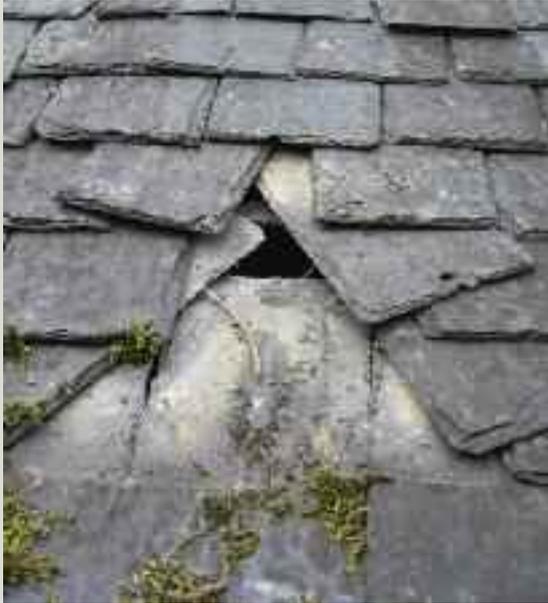
Earlier slate roofs using top-hung, single-nailed slates can easily be repaired by swinging individual slates aside allowing access to replace or re-peg the slates beneath

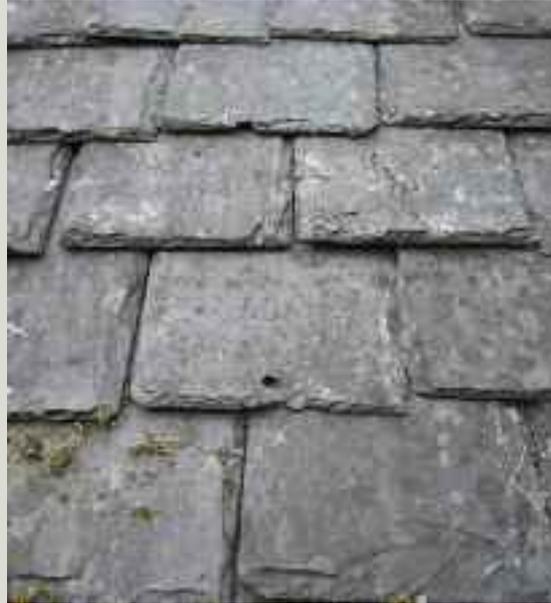
Slates are swung back into place after works

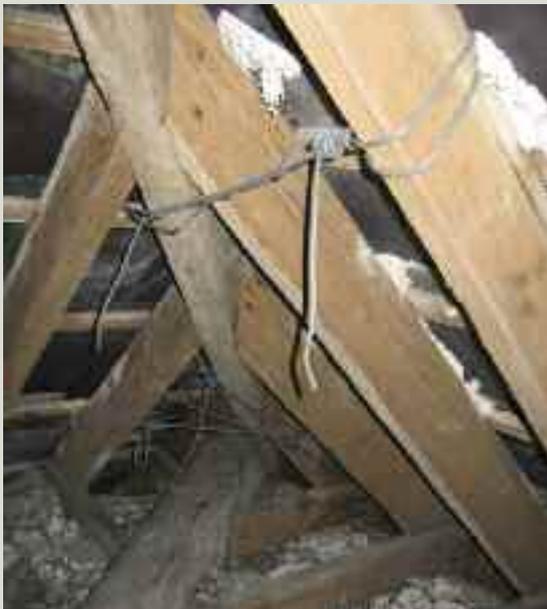
An alternative repair method is to tie the slates within the roof. This is useful where the slates are large or have square shoulders or, for some other reason, cannot be swung aside. A plastic-coated wire such as electrical lighting wire is threaded through the gap from inside the roof and attached to the slate outside. The slate is then carefully pulled back into position and the wire tied back to the timber roof structure

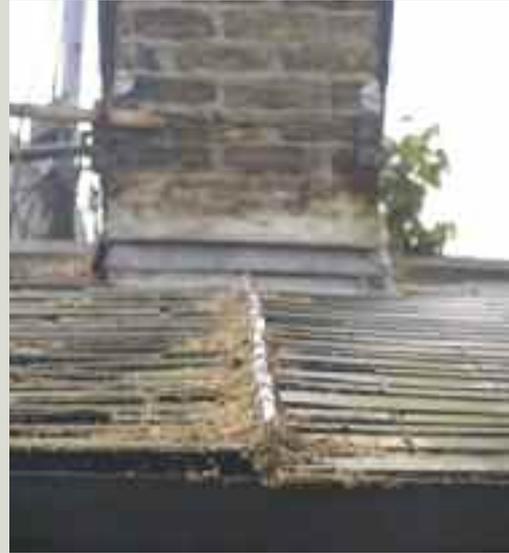
A lead divider batten roll can be used to disguise a difference in level caused by the use of deeper battens. The use of larger battens when re-roofing or the use of counter-battening with roof membranes can mean an increase in the roof plane height. This causes a difference in height between roofs in a terrace of buildings and a lead soaker may be used to accommodate the difference in levels

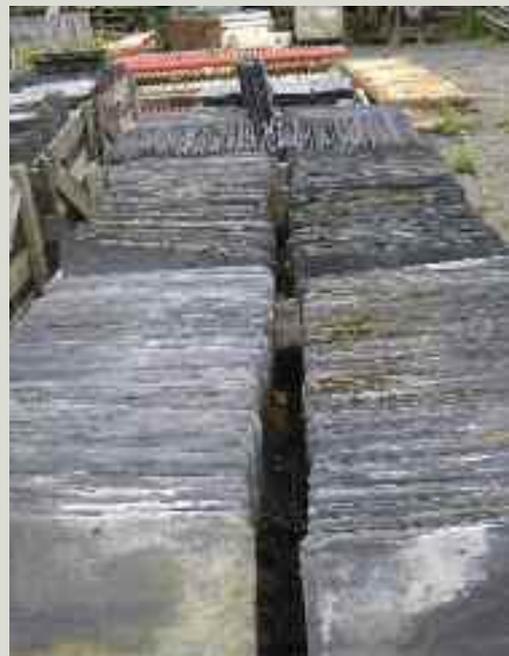
Slates properly stripped and sorted

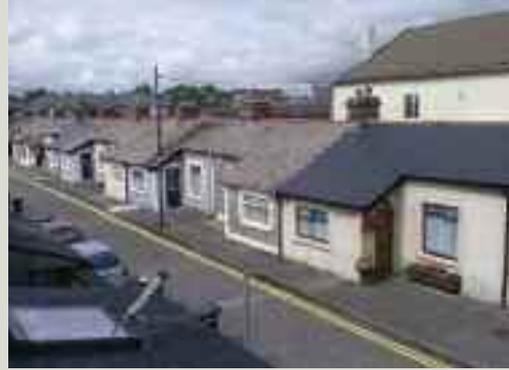
The mix of roofing materials on this terrace of houses visually fragments its appearance. The use of 'artificial slate', or fibre-cement tile is visible in the foreground, and also further down the street, striking discordant notes among the original slate-covered roofs

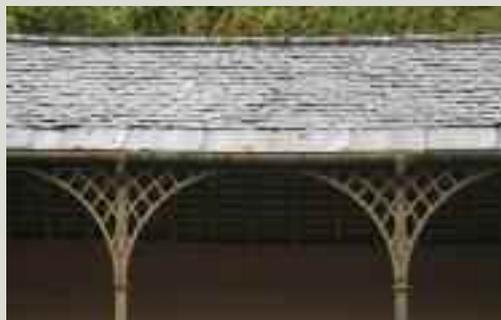
Large eaves slates helped to ensure that a good weatherproof detail was achieved where the accumulation of rainwater was greatest. It is a particular feature of historic slate roofs and should be retained when undertaking repair works

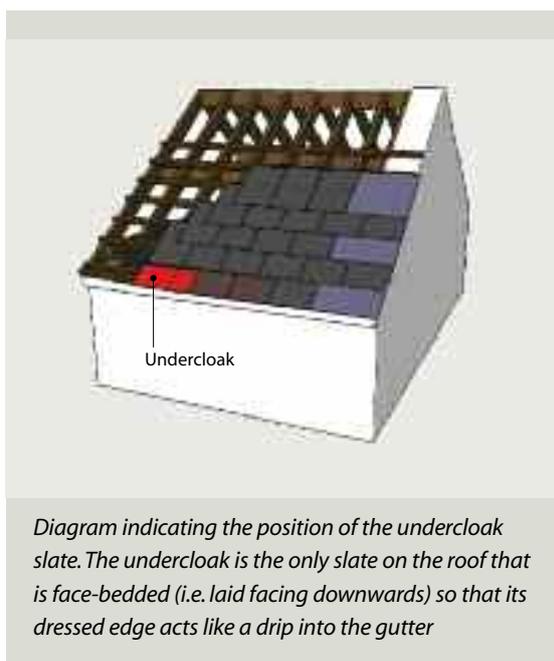
Diagram indicating the position of the undercloak slate. The undercloak is the only slate on the roof that is face-bedded (i.e. laid facing downwards) so that its dressed edge acts like a drip into the gutter

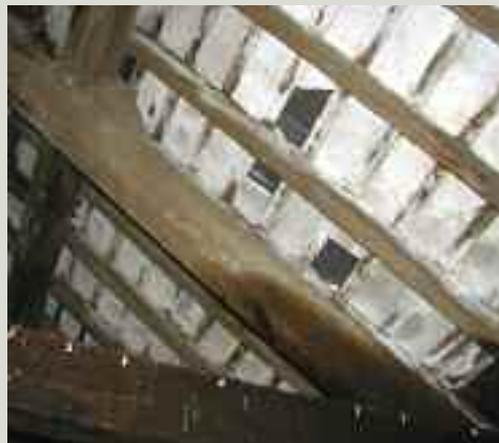
Substantially intact parging to the underside of slates is visible from within the attic space and provides a secondary line of defence against rain and wind entering the interior of the building

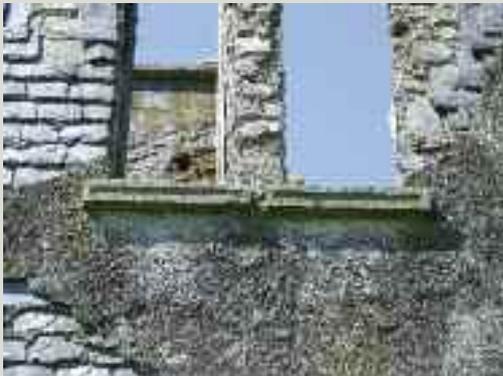
On this ruinous house in County Cork, the vertically hung slates, bedded in lime mortar, were later rendered over. Their existence only came to light as the external render decayed and fell off

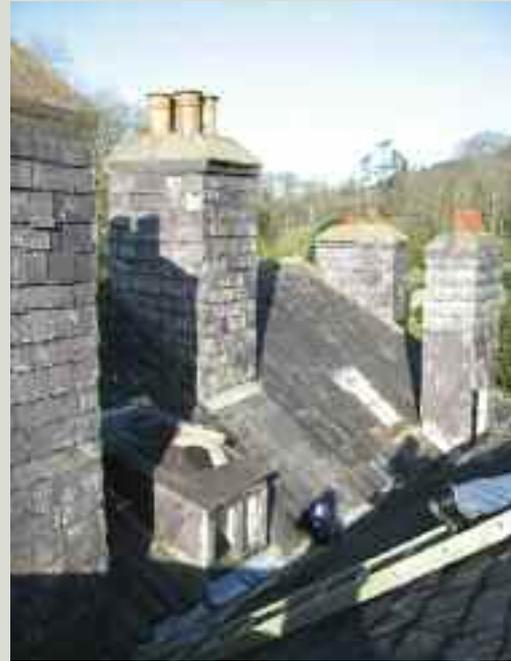
The change in colour of the slate on the chimneystack in the background indicates where a number of courses were removed and replaced. In areas of extreme weather exposure, vertically hung slating gives increased protection to the stacks

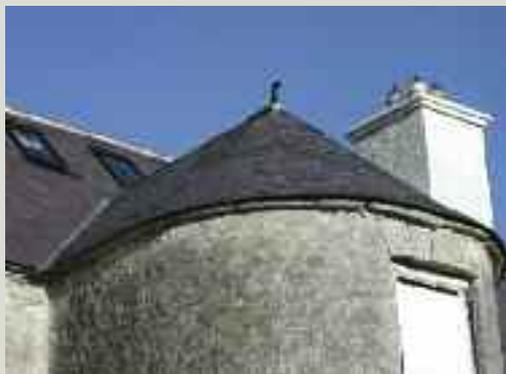
The repair of curved slate roofs is highly specialised work and requires a roofing contractor who has experience and skill in gauged work

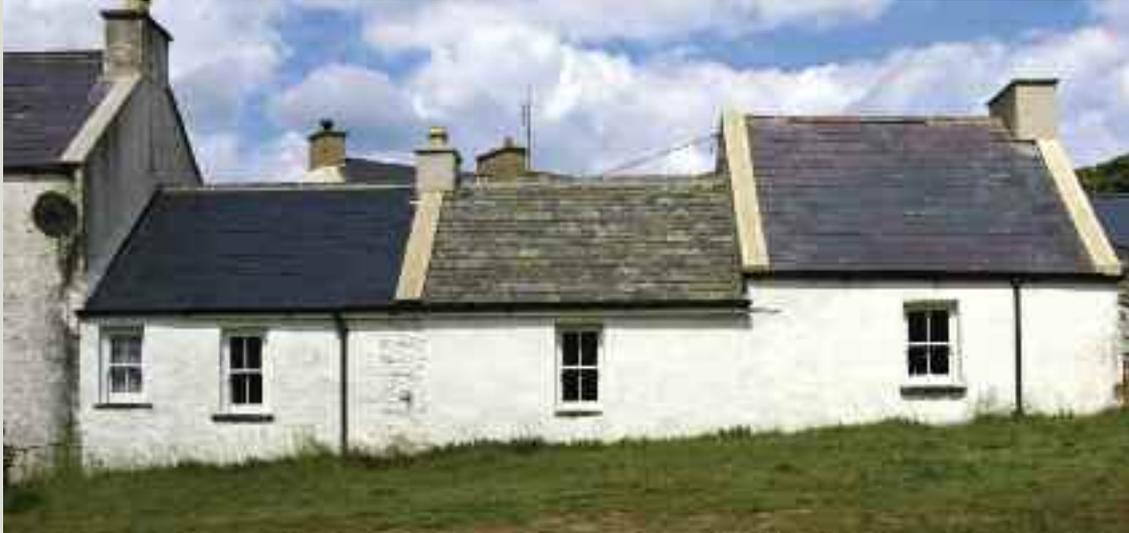
Most buildings using stone roofing slate are distinguishable by their simple gable-ended roofs. Hipped profiles, dormer windows, and valleys are difficult to achieve because of the large and somewhat unwieldy nature of the stone slate

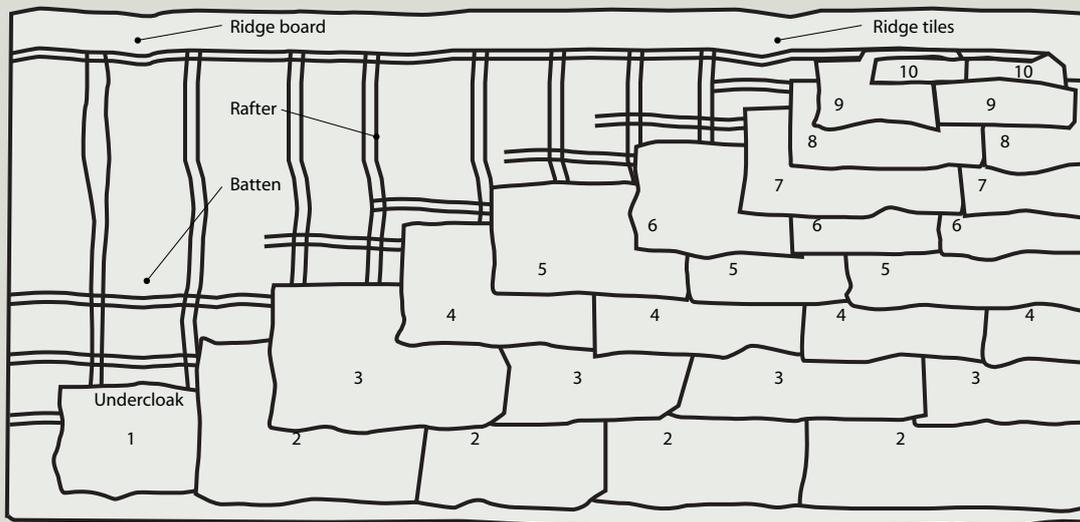
Graduated stone slates
Note: the distance between the battens decreases towards the top of the roof

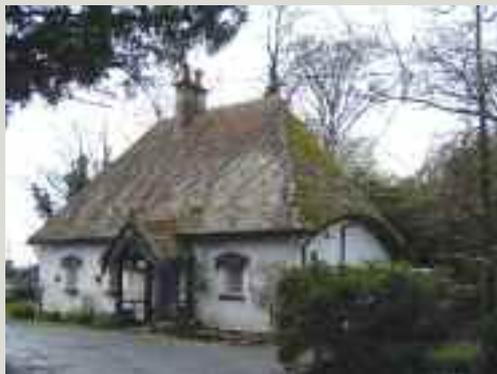
A gate lodge with a decorative clay-tiled roof, having striking curved elliptical eaves and a patterned use of plain and scalloped tiles. Overhanging branches and the proximity of large trees have tended to promote extensive moss growth on part of the roof

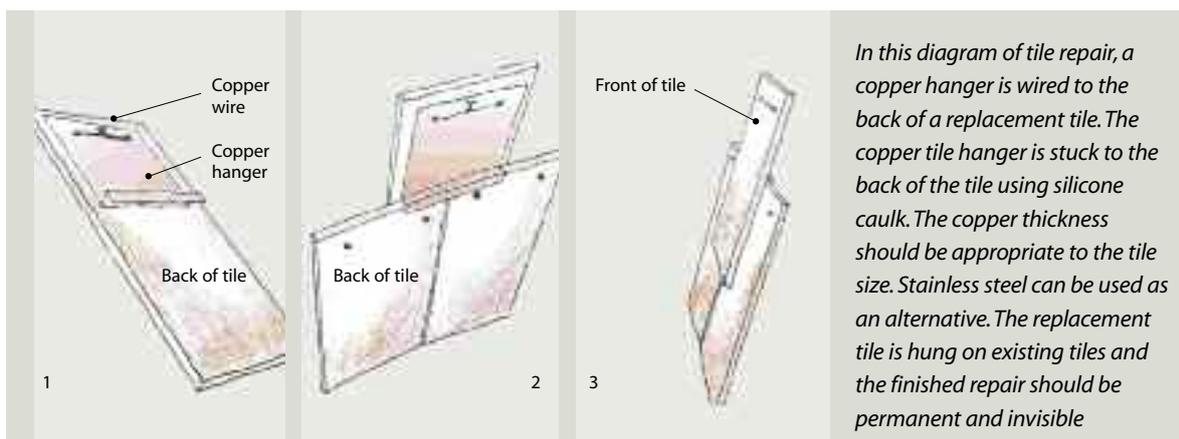
REPAIR OF TILED ROOFS

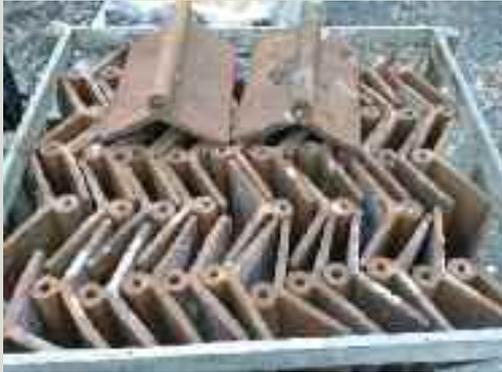
There is a wide range of clay ridge tiles available, including ornamentals, which enhance the character of a roof. These should be repaired or replicated as necessary, but not introduced unless there is evidence of their use on the building

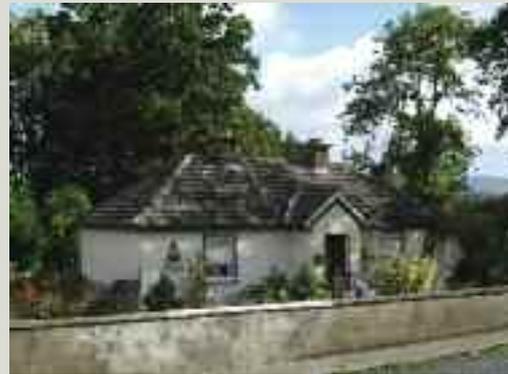
A Marley concrete roof tile on this modest 1940s cottage

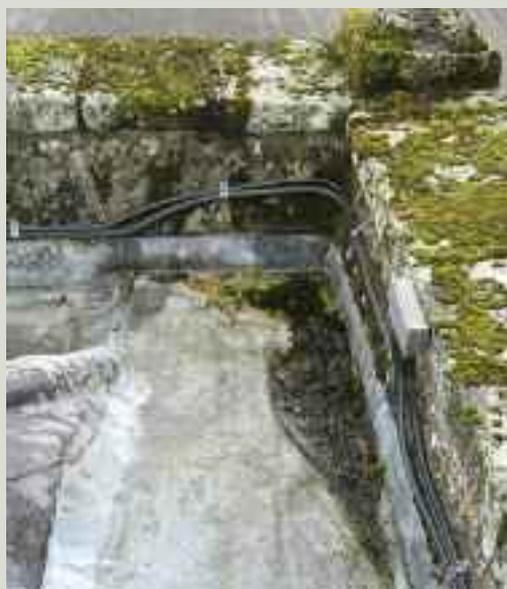
Ponding of water away from gutter outlets indicates a problem with the substrate timbers. In this case, a likely cause was poorly functioning flashings at the junction with the parapet wall

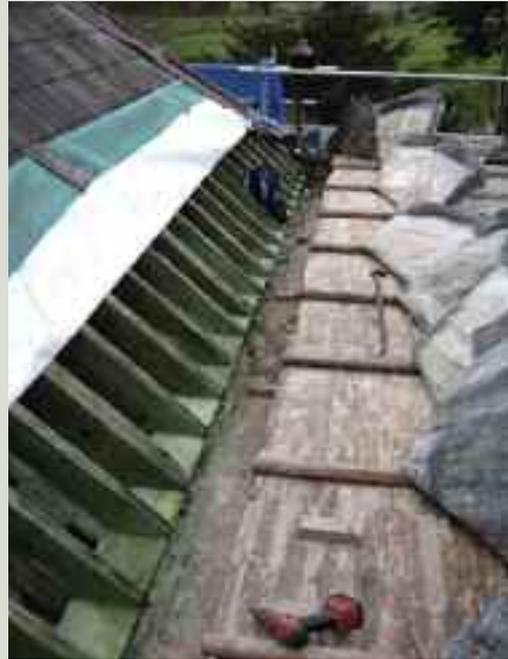
Slight lead corrosion can be seen on the exposed underside of the lifted lead sheeting on the right. The main problem here was a poorly detailed gutter. There was no need to change the regime of the flat roof, although good practice would include an underlay between the deal boards and the sheet lead

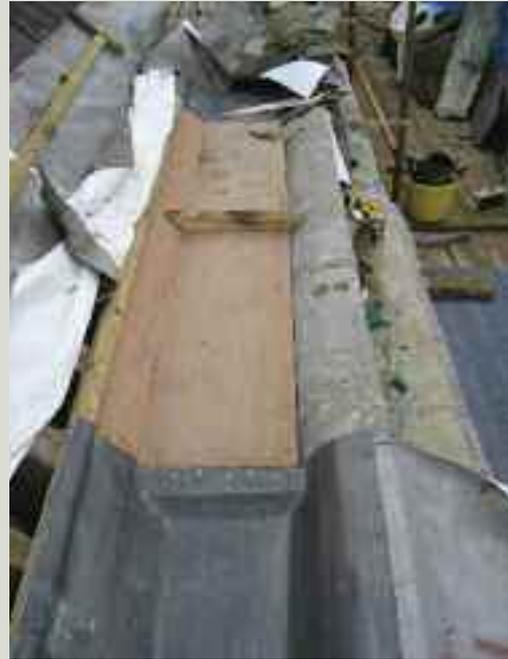
The design of this parapet gutter has been revised to achieve correct lead sheet lengths, falls and step heights in order to ensure that the newly-laid gutter will achieve a good lifespan. Note that the lead sheets have been fixed at the top end only (to allow for expansion and contraction), using copper nails in a staggered pattern

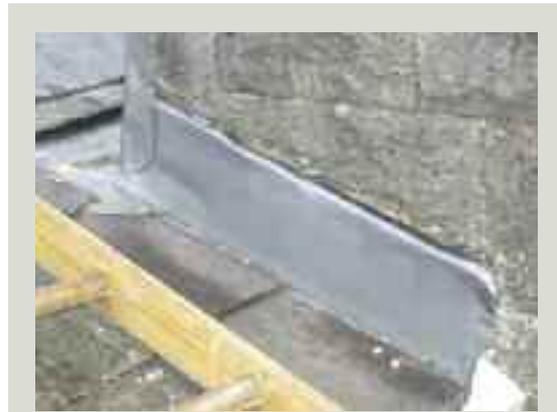
New lead flashing over lead soakers, turned into a mortar joint in the stonework at the base of a chimneystack and fixed using lead welts. The mortar joint is yet to be repointed

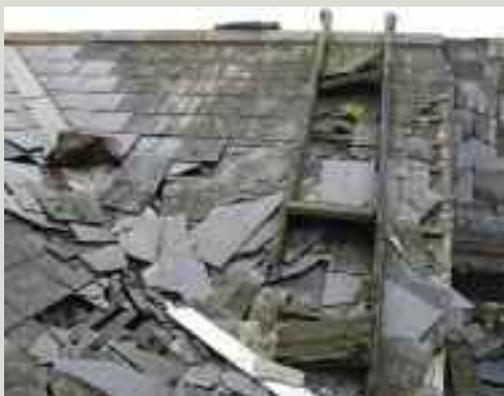
The theft of lead and copper from a historic roof can cause significant damage and leaves the interior of the building vulnerable to further damage from flooding

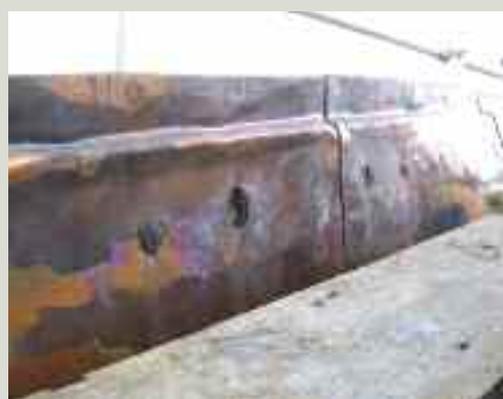
This copper parapet gutter lining has been lifted for inspection following water penetration problems. The bright salmon-coloured areas indicate that corrosion is occurring. Holes in the copper had been previously filled with a bitumen product in an earlier repair attempt which has exacerbated the problem, as bitumen corrodes copper

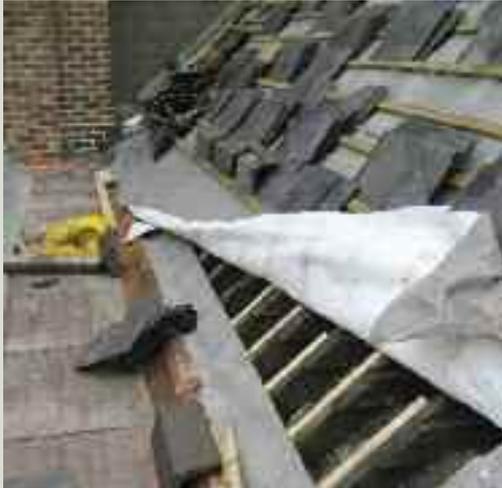
Re-lining a valley gutter in copper. Splice repairs were required to the ends of rafters where the previous valley had leaked over a significant length of time, causing decay of the timber structural elements below

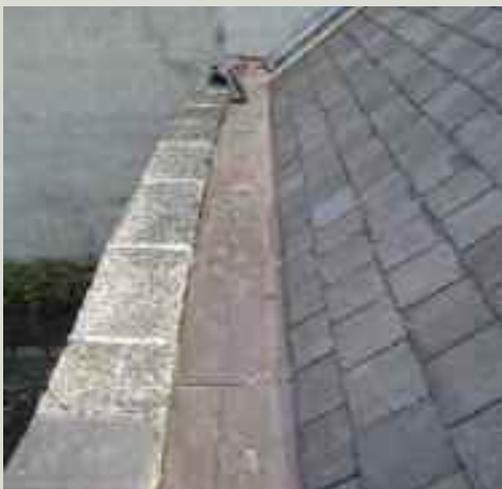
Parapet gutter re-lined in copper. The very shallow falls to this gutter precluded the use of lead

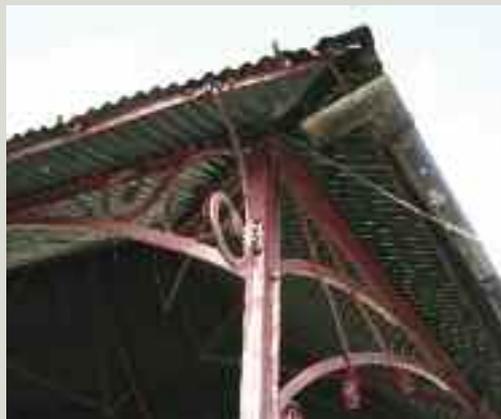
This corrugated iron is suffering from pitting, visible as small pinpricks of light where the metal has corroded through. There is also crevice corrosion occurring at the junction of the sheet with the hip roll. In addition, work is urgently needed to repair the rainwater goods

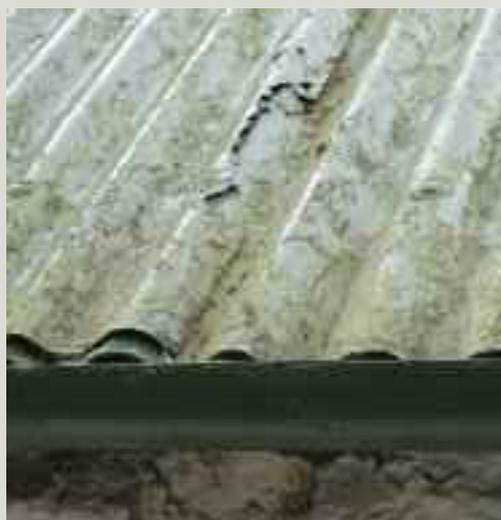
Crevice corrosion is frequently a problem with corrugated iron, particularly at the laps between corrugated sheets

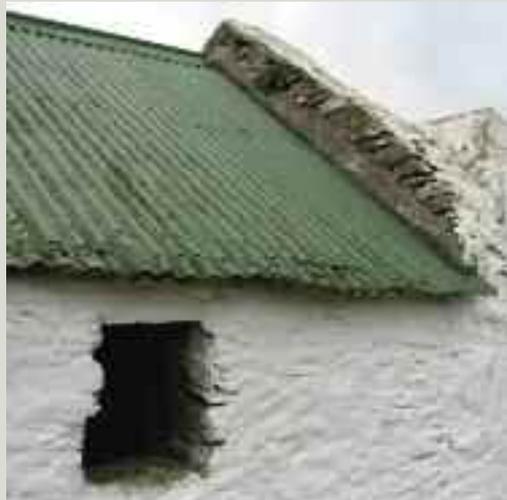
The eaves edge of corrugated-iron sheeting is particularly vulnerable to corrosion. Here, additional layers have been inserted under the eaves

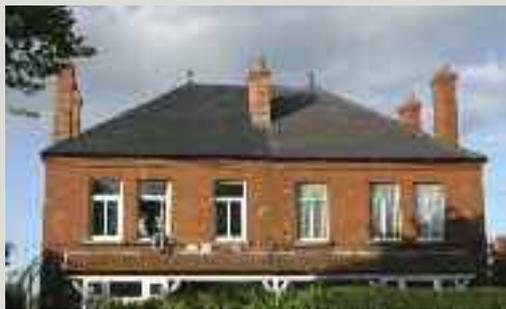
A recently replaced Welsh slate roof (to the left) adjoining a historic one (right), where the difference of character, colour and texture can easily be seen

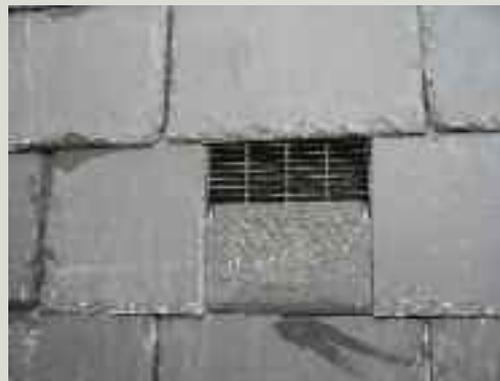
Example of an in-line slate vent. The vent will not protrude above the roof plane. However, such vents may be unacceptably conspicuous if used on the outward-facing slopes of a roof

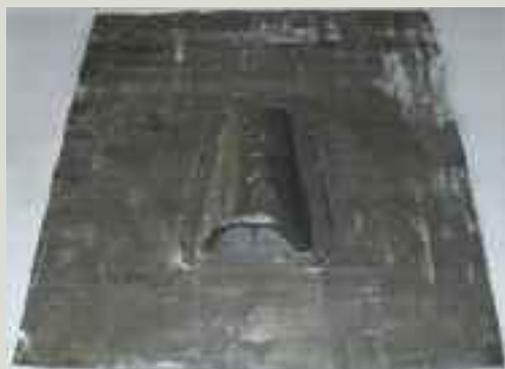
An especially formed lead vent with fly mesh, for use on a church roof. As they are quite distinctive and visible, the use of these vents on a roof where none existed previously should be discussed with the architectural conservation officer in the local authority

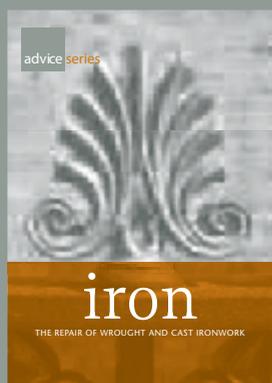
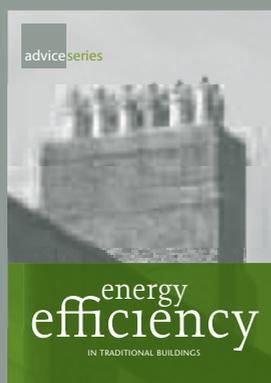
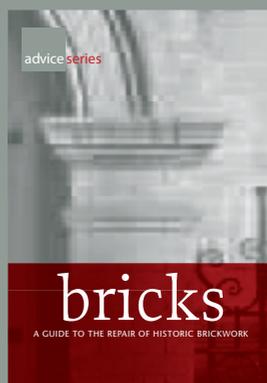
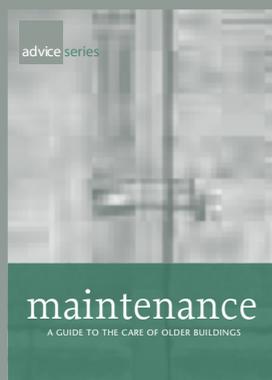
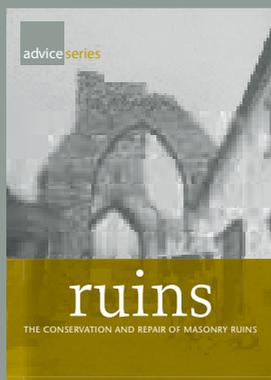
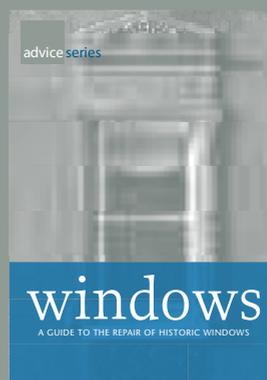
This guide will advise you in caring for your historic roof, helping you to:
